# VÝSTAVBA PODZEMNÍHO VÝUKOVÉHO STŘEDISKA JOSEF V OPUŠTĚNÉM DŮLNÍM DÍLE MOKRSKO – ČELINA

## CONSTRUCTION OF THE JOSEF UNDERGROUND EDUCATIONAL FACILITY IN THE ABANDONED MINE OF MOKRSKO – ČELINA

VLADIMÍR PRAJZLER

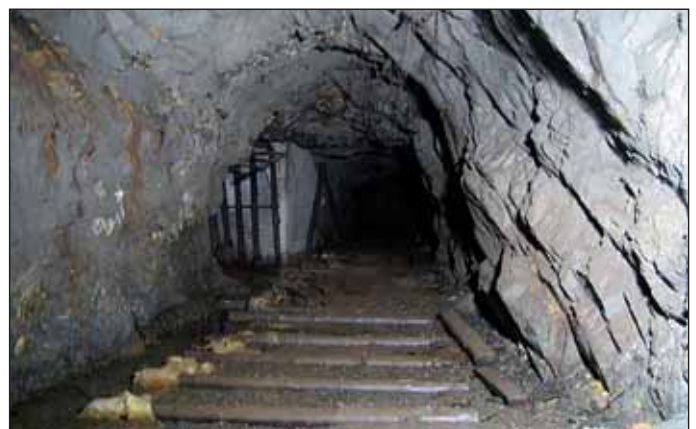
Obr. 2 Odbočení k akumulátorovně, původní stav po otevření štoly  
Fig. 2 Turning to battery charging station, original situation after gallery opening

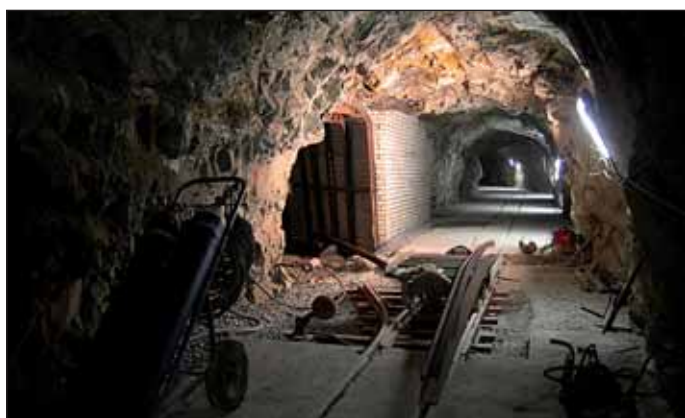
Obr. 3 Odbočení k akumulátorovně, stav před dokončením  
Fig. 3 Turning to battery charging station, situation before finishing

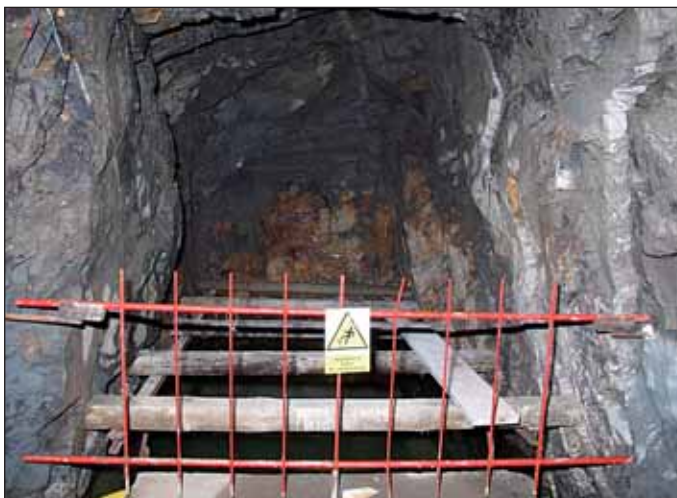
Obr. 4 Usazovací jímka ve štolě  
Fig. 4 Sump in the gallery

Při úpravách štoly byla jámka vypuštěna a vyčištěna. Při provozu výukového střediska bude sloužit jako usazovací jámka přítoků ze vzdálenější části překopu a z bočních štol. Je opatřena betonovou ohlubení a zábradlím proti pádu osob. Drenážní potrubí je před jámkou přerušeno, tak aby voda protékala přes jámku, z jámky odtéká přepadem směrem k portálu.

The sump was discharged and cleaned during the main gallery alterations. During the operation of the Educational Facility, it will serve as a sump for affluent from distant main gallery parts and from side galleries too. It is equipped with a concrete pit bank and protective railings to prevent falls. The drainage pipe is disconnected before the sump so the water flows through the sump with the overflow towards the portal.

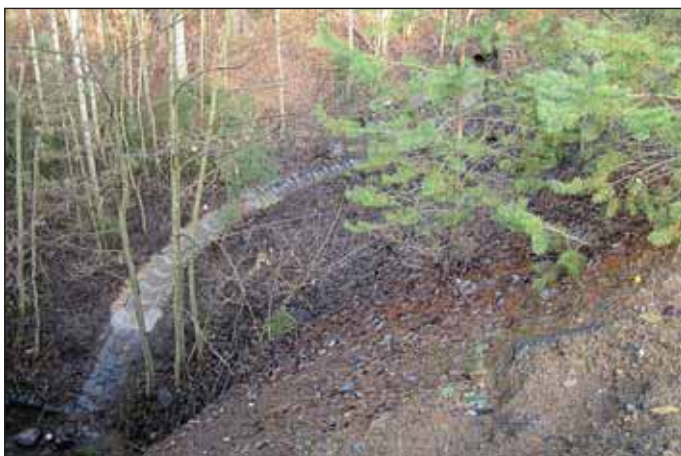
Obr. 5 Zaústění odvodnění do potoka  
Fig. 5 Outlet of the drainage system

The drainage is connected to the original steel pipe leading to a flume at the portal, through which the drainage system leads into the Čelinský Brook. According to the requirements of the brook management (Forests of the Czech Republic), a plastic septic tank was mounted on the pipeline and the flume was cleaned and repaired.

ke korytu, kterým je odvodnění zaústěno do Čelinského potoka. Podle požadavku správce potoka (Lesů ČR) byla na potrubí osazena plastová usazovací jímka, koryto bylo vyčištěno a vyspraveno.

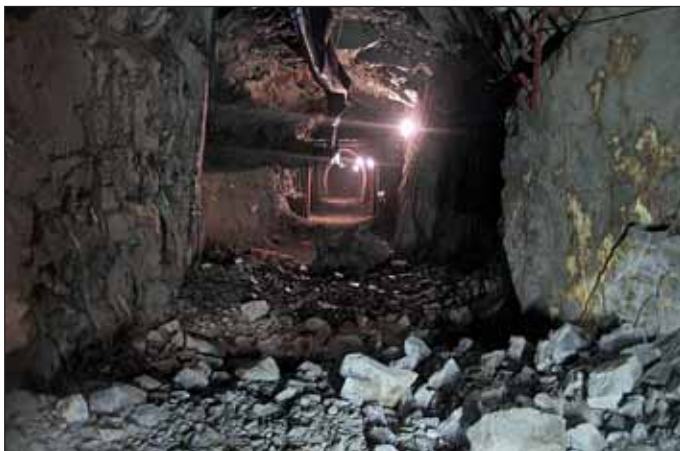
Obr. 6 Flexibilní lutny v překopu SCH-Z/SP 11  
Fig. 6 Flexible pipes in the cross-cut SCH-Z/SP 11

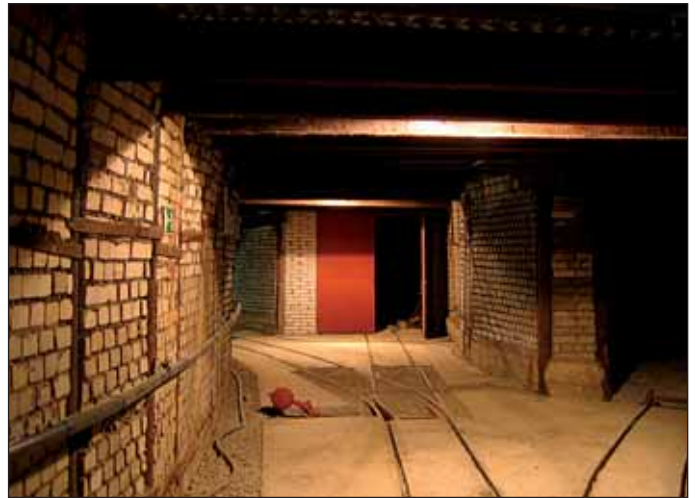
Obr. 7 Větrní vrata na překopu  
Fig. 7 Air-lock door of the cross-cut

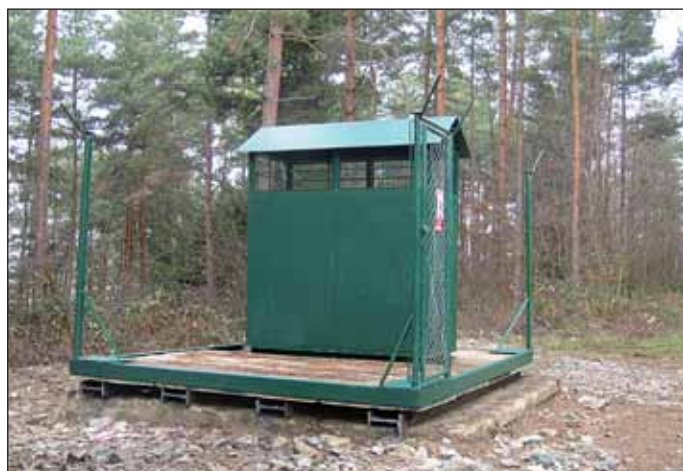
Obr. 8 Větrací objekt na ohlubení větracího komínu  
Fig. 8 Ventilation unit on vent shaft pit bank

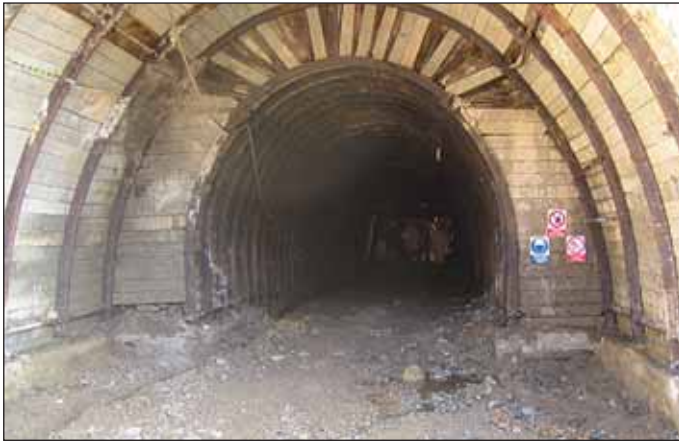
Obr. 9 Portál štoly po otevření v září 2006  
Fig. 9 Gallery portal after opening in September 2006

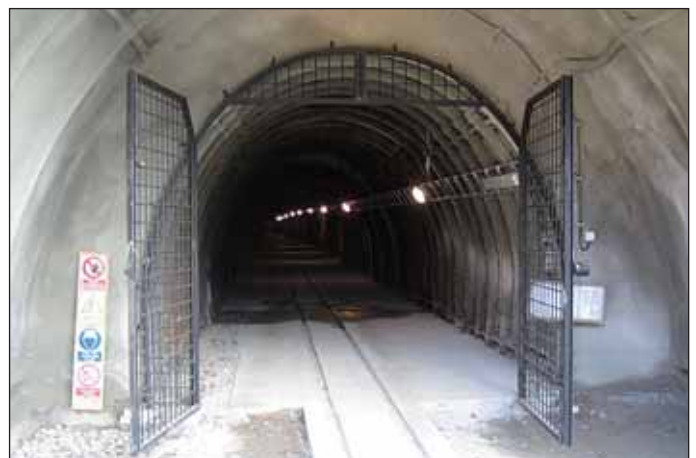
Obr. 10 Portál štoly po osazení mřížových vrat v únoru 2007  
Fig. 10 Gallery portal after installation of grated gate in February 2007

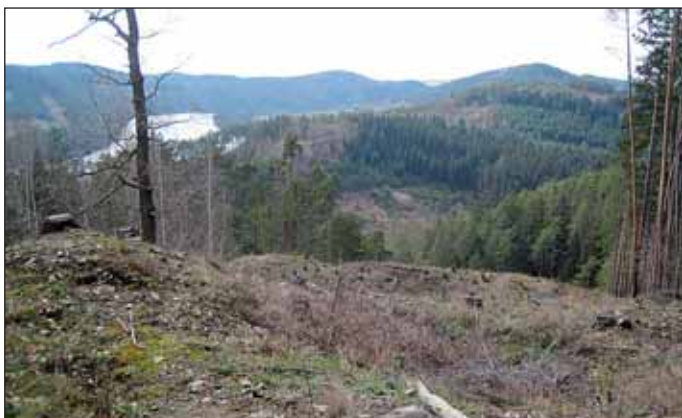
Obr. 11 Staré práce nad portálem  
Fig. 11 Old works above the portal
