SPECIFIKA NAVRHOVÁNÍ HLOUBENÝCH TUNELŮ A PŘÍKLADY Z REALIZACE

SPECIFICS OF DESIGNING CUT-AND-COVER / COVER-AND-CUT TUNNELS; EXAMPLES OF IMPLEMENTATION

LIBOR MAŘÍK

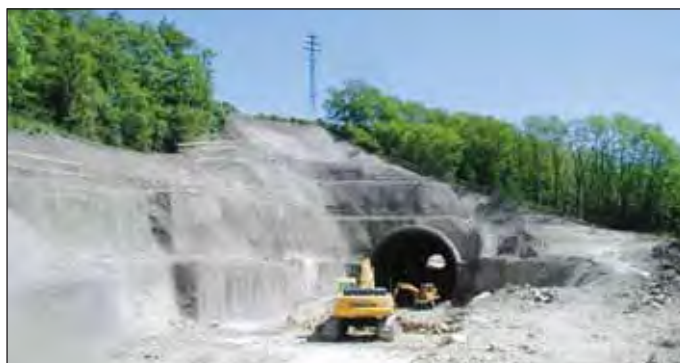
Obr. 1 Asymetrická stavební jáma tunelu Vepřek
Fig. 1 Asymmetric construction trench – the Vepřek tunnel

K typickým příkladům nesymetricky zatížených úseků hloubených tunelů vlivem reliéfu terénu patří dvoukolejný železniční tunel Vepřek na prvním železničním koridoru Praha–Děčín–Dráždany. Směrové poměry stávající trati vedené podél břehu řeky Vltavy neumožňovaly dosažení vyšší traťové rychlosti. Úprava směrových poměrů vyvolala nutnost vedení trati v úbočním tunelu s velmi nepříznivým úhlem zaražení tunelu v oblasti obou portálů. Tomu odpovídal tvar stavebních jam hloubených úseků tunelů i úroveň zpětného zásepů (viz obr. 1). Hloubka svahovaných stavebních jam dosahovala v místě rozhraní hloubené a ražené části 30 m. Konečný příčný sklon terénu, prováděný v poměru 1:2 až 1:3, vyvolával kvůli nesymetrii výšky zásepů v ostění tunelu nesymetrické namáhání, které mělo rozhodující vliv na návrh vyztužení. Při tloušťce ostění min. 600 mm se vyztužení na straně přivrácené ke svahu markantně lišilo od strany přiléhající k Vltavě. Na základě statického posouzení postupných fází zasypávání konstrukce i konečné úrovně zásepů navrhl projektant pracovní postup provádění zásepů, který zhotovitel velmi důsledně dodržoval. Principem bylo zahájení zásepů na straně tunelu přivrácené k řece, důsledné hutnění zásepového materiálu na předepsané parametry a dodržování rozdílu úrovně zásepů vlevo

The double-rail Vepřek tunnel on the first rail corridor between Prague – Děčín – Dresden is one of typical examples of sections of cut-and-cover tunnels loaded asymmetrically due to the surface relief. The horizontal alignment of the existing track, running along the Vltava River, did not allow increasing the speed limit over the track. A change in the horizontal alignment brought about the necessity of leading the track through a hillside tunnel with a very unfavourable angles of the tunnel entering the hill at both portals. The shape of the construction trenches for the cut-and-cover tunnels and the level of the backfill corresponded to this situation (see Fig. 1). The depth of sloped excavation trenches at the interface between the cut-and-cover and mined sections reached 30m. The final transverse slope of the terrain, which was carried out at a ratio of 1:2 to 1:3, induced, owing to the asymmetry of the backfill height, asymmetric stresses in the lining, which had the deciding effect on the reinforcement design. With the minimum thickness of the lining of 600mm, the reinforcement content on the side facing the slope markedly differed from the side adjacent to the Vltava River. The designer proposed a working procedure for the backfilling on the basis of a structural assessment of consecutive phases of backfilling of the structure and the final level of the backfill. The procedure was thoroughly adhered to by the contractor. The principle was that backfilling started on the tunnel side facing the river, the backfill material was consistently compacted to reach prescribed parameters and the maximum difference between the backfill levels on the left side and right side of the structure was held at 1m. Confusion in the installation of concrete reinforcement on the left side and right side of the lining structure could have become a source of a fatal error. For that reason the designer added a legend ‘toward the mountain’ or ‘toward the river’ in reinforcement

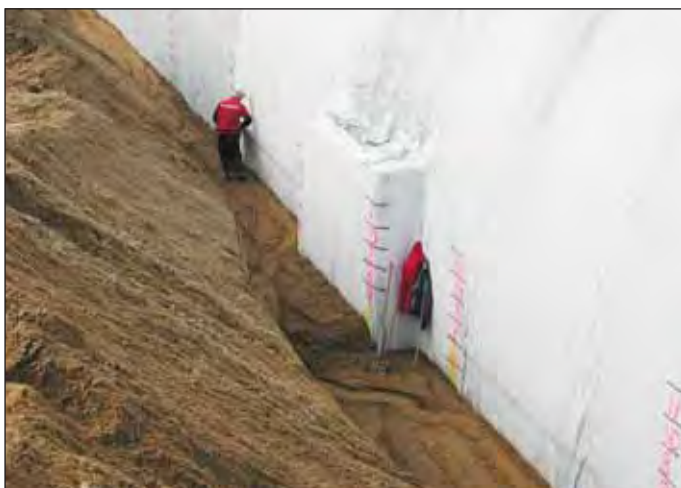
Obr. 2 Postupné obsypávání tunelu podle rysek na geotextilii
Fig. 2 Gradual backfilling of the tunnel according to marks on the geotextile

a vpravo konstrukce do max. 1 m. Zdrojem fatální chyby mohla být záměna výztuže na levé a pravé straně ostění. Výkresy výztuže proto projektant doplnil o popis „k hoře“ a „k řece“, které jednoznačně určovaly, kam má být výztuž v konstrukci umístěna. Zhotovitel přistoupil k navrženému technologickému postupu velmi zodpovědně a výstavba proběhla bez komplikací. Technologický postup hutnění usnadňovalo značení jednotlivých úrovní hutnění, které zhotovitel vyznačil na geotextilii, která sloužila jako ochrana hydroizolační fólie (viz obr. 2).

drawings, unambiguously marking the location for reinforcement bars where they were to be placed. The contractor's attitude to the proposed technological procedure was highly responsible; the construction was carried out without complications. The technological procedure for the compaction work was facilitated by marking of individual levels of the compacted backfill on either side. Marks were made on the geotextile protecting the waterproofing membrane (see Fig. 2).

pouze pomocí geotextilie 800 g/m² a šterkopískovým obsypem (viz obr. 2). Díky precizní a bezchybné práci zhotovitele Metrostav se podařilo hloubené úseky dokonale zaizolovat a po 8 letech provozu lze konstatovat, že hydroizolační fólie plní svou funkci.

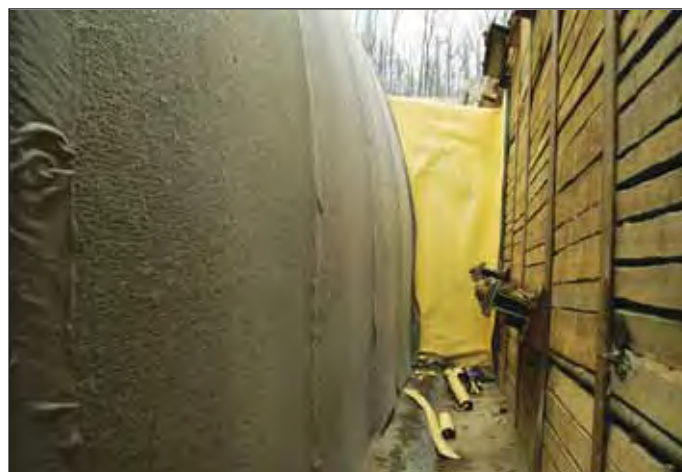
Obr. 3 Omezený prostor ve stavební jámě Komořany tunelů stavby 513
Fig. 3 Constricted space in the Komořany construction trench for the PCCR 513 tunnels

Hlubené tunely v oblasti portálu Komořany stavby 513 silničního okruhu kolem Prahy (SOKP) představují příklad, který se zpočátku jevil z hlediska zatížení jako zcela bezproblémový. Dva paralelní tubusy hlubných tunelů délky 170 m, prováděných v pažené stavební jámě šířky 50 m a hloubky téměř 30 m, překrývala v nejhlubším místě jámy vrstva až 15 m horizontálně uloženého zásypového materiálu. Zatímco volný prostor mezi oběma tunely dosahoval u portálu šířky jen 4 m, mezi bokem tunelu a pažením stavební jámy volná šířka nepřekračovala 1,5 m. Do tohoto již tak velmi úzkého prostoru zasahovaly jednak převázky a hlavy lanových kotev stabilizujících pažení stavební jámy, jednak výklenky pro kabiny SOS, které se zadní stěnou opíraly o pažení a uzavíraly tak průchod do dalšího úseku jámy (viz obr. 3). Celou situaci komplikovaly i základové poměry. I když se podle prognózy stanovené na základě IG průzkumu měly mělce pod masivní základovou klenbou již nacházet jílovité břidlice, zastihl zhotovitel při hloubení stavební jámy mohutnou vrstvu písků. Na tuto skutečnost bylo nutné rychle reagovat a na způsob provádění a ochrání základové spáry nepanoval jednotný názor. Zaznívaly hlasy prosazující přehutnění nebo dokonce výměnu podloží. Vzhledem k jemnozrnnosti a mocnosti vrstvy písků nakonec převážil názor na ponechání ochranné vrstvy rostlého materiálu tloušťky min. 1 m a tvarování základové spáry s ústupem tak, aby nebyla pojižďena mechanizmy. Po vytvarování spáry do tvaru klenby následoval ochranný nástřik betonu, betonáž podkladního betonu a montáž výztuže. Pokud došlo z jakéhokoli důvodu k nakypření základové spáry, byl materiál vyměněn za vrstvu monolitického betonu. Práce probíhaly za přísného dozoru investora i zhotovitele a po úspěšném založení proběhla stejně

The cut-and-cover tunnels in the area of the Komořany portal of the construction lot 513 of the Prague City Circle Road (PCCR) are an example of a construction which appeared in the beginning as absolutely trouble free as far as the loading was concerned. Two parallel 170m long tubes of the cut-and-cover tunnels, which were constructed in a 50m wide and nearly 30m deep construction trench, were covered in the deepest point of the trench by an up to 15m thick horizontally deposited backfill material. While the width of the free space between the two tubes reached a mere 4m at the portal, the free width of the gap between the tunnel side and the excavation bracing did not exceed 1.5m. In addition, walers and heads of cable anchors stabilising the construction trench bracing extended into this, anyhow very narrow, space. Recesses for SOS cabins also clogged this space. Rear walls of the cabins leaned against the bracing, thus hampering the passage along, to the neighbouring section of the construction trench (see Fig. 3). The whole situation was further complicated by the foundation conditions. Despite the fact that, according to the EG survey, clayey shales were to be found already at a shallow depth under a massive invert, the contractor encountered a huge layer of sand during the excavation of the construction trench. This fact had to be quickly responded to, but the opinion on the method of executing the work and protecting the foundation base was not unified. Voices were heard pushing through overcompaction or even replacement of the foundation bed. Taking into consideration the fineness of the sand and thickness of the sand layer, the opinion finally prevailed that an at least 1m thick protective layer of native material should be left untouched, and the foundation base be uncovered step by step to avoid driving of construction equipment on it. When the shaping of the foundation base into the shape of the inverted arch had been completed, a protective layer of shotcrete was applied, then blinding concrete was placed and reinforcement installed. If, for any reason, the foundation base got loosened, the loose material was replaced by a layer of cast-in-place concrete. The work proceeded under strict supervision by the owner and the contractor. When the foundation had been successfully completed, the lining of the cut-and-cover tunnel sections was cast with the same success. Individual phases of the construction procedure are presented in Fig. 4, showing the foundation base covered with blinding concrete, the installation of reinforcement and, in the background, the casting of the tunnel invert. The work on the backfill was accompanied by complications associated with the insufficient space between the tunnels and the bracing of the construction trench. For structural reasons, it was necessary at the two casting blocks adjacent to the mined tunnels to fill the space between the tunnels and the construction trench wall and between the two tunnel tubes with lean concrete. This action ensured sufficient rigidity of the support of tunnel sides. Without this measure, it would have been impossible to design dimensions of the structure without substantial measures, despite the fact that the thickness of the lining in the crown reached 1m and gradually increased on the sides up to 2m. In the remaining section where the overburden was higher, the backfill of the construction trench consisted of sand (on the tunnel sides) or crushed muck from the tunnel (in higher parts of the trench). Various types of compaction equipment were used, depending on the space available between the tunnel tubes and along the construction trench bracing. Despite all efforts, it is obvious that the attempt to achieve uniform rigidity of the backfill on

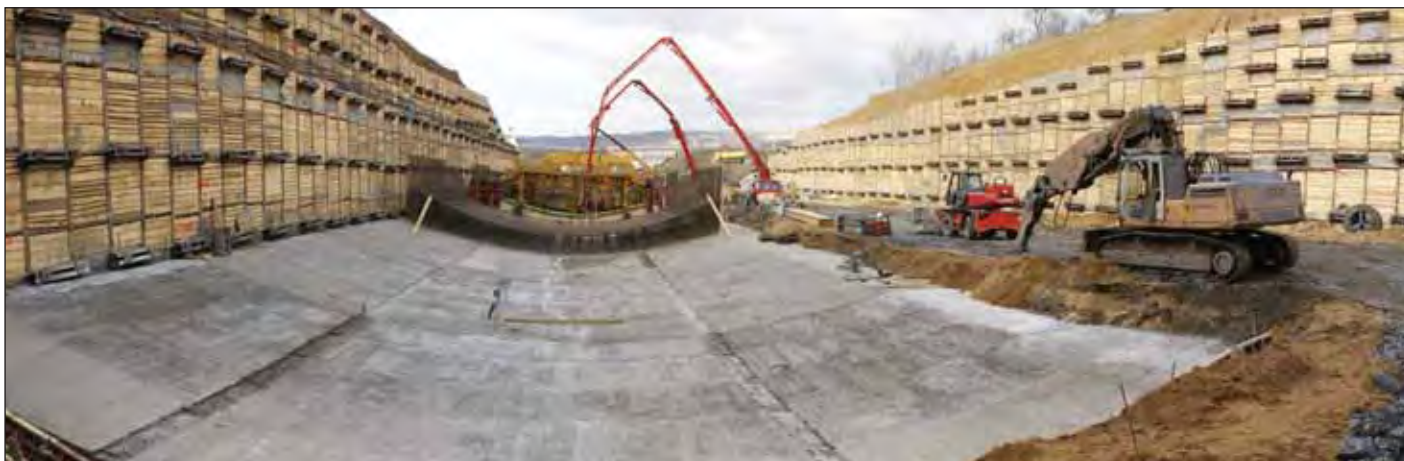
Obr. 4 Postup výstavby ve stavební jámě Komořany
Fig. 4 Construction procedure in the Komořany construction trench

úspěšně i betonáž ostění hloubených úseků obou tunelů. Jednotlivé fáze postupu výstavby viz obr. 4, na kterém je patrná úprava základové spáry podkladním betonem, montáž výztuže a v pozadí probíhající betonáž spodní klenby tunelu. Provádění zpětných zásypů provázely komplikace spojené s nedostatečným prostorem mezi tunely a pažením stavební jámy. Ze statických důvodů bylo nutné u prvních 2 bloků betonáže před raženými tunely s nejvyšší vrstvou zásypu provést vyplnění prostoru mezi tunely a stěnou jámy i mezi oběma tubusy tunelů hlubným betonem, což zajistilo dostatečnou tuhost podepření boků tunelů. Bez tohoto opatření by nebylo možné konstrukci bez větších úprav nadimenzovat, i když tloušťka ostění dosahovala ve vrcholu klenby 1 m a do boků se rozšiřovala až na 2 m. Ve zbývajícím úseku s nižším nadloží byl pro zásyp stavební jámy použit na bocích tunelu písek a ve vyšších partiích jámy předrcená rubanina z tunelu. Vzhledem k prostorovým možnostem probíhalo hutnění mezi tunely a podél pažení stavební jámy různými mechanismy. Přes veškerou snahu se zřejmě nepodařilo dosáhnout stejné tuhosti zásypu po obou stranách konstrukce a následkem toho došlo k nesymetrickému zatížení konstrukce, přestože úroveň definitivního terénu po provedení zásypu je v příčném řezu vodorovná. Nesymetrii zatížení vlivem nerovnoměrného hutnění ukázala až geodetická měření deformace ostění, prováděná v měřickém profilu, obdobně jako tomu je při měření deformací primárního ostění. Pootočení a posun tunelu nezpůsobila v tomto případě neúnosnost podloží, ale způsob provádění zásypu, kdy docházelo k deformaci ostění směrem do obtížně zhutitelného zásypu na bocích tunelu. Tomu odpovídá na obr. 5 vektorové znázornění deformace ostění obou tunelových trub.

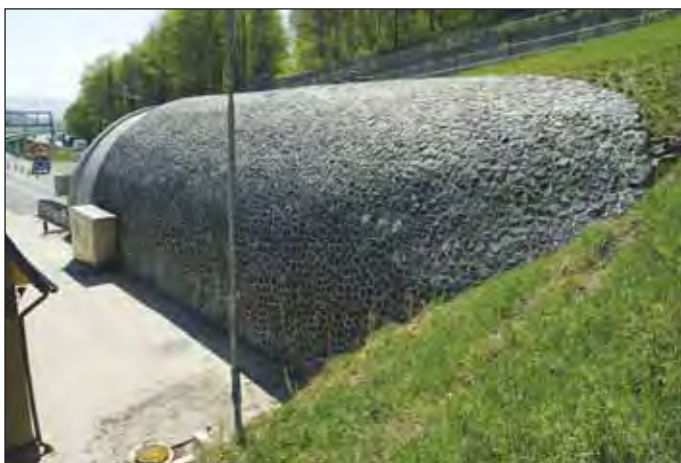
Obr. 6 Obklad jednostranně obnaženého portálového bloku tunelu Libouchec
Fig. 6 Cladding of the exposed side of the Libouchec tunnel portal block

Nejmarkantnějším příkladem asymetrického zatížení hloubených tunelů je portálový úsek tunelu Libouchec na dálnici D8 v úseku z Ústí nad Labem na státní hranici ČR/SR. V případě jižního portálu tunelu Libouchec měla být východní tunelová trouba s ohledem na provádění zásypů a sklony násypových těles prodloužena v průběhu výstavby až o 24 m. Z prostorových důvodů nebylo možné zásadně měnit dispoziční uspořádání v oblasti portálu a posouvat provozně technologický objekt tunelu. Zásyp byl proto ukončen v úrovni vrcholu klenby tunelu a jeho východní bok přiléhající k provozně-technologickému objektu byl zcela obnažen. Estetické pojetí obkladu obnaženého boku tunelu v krajině Krušných hor ukazuje obr. 6. Ostění pod čedičovým obkladem je z vodonepropustného betonu.

The most marked example of asymmetric loading on cut-and-cover tunnels is a portal section of the Libouchec tunnel on the D8 motorway in the section between the city of Ústí nad Labem and the border between the Czech Republic and Germany. In the case of the southern portal of the Libouchec tunnel, the eastern tunnel tube had to be extended during the course of the construction by up to 24m with respect to the backfilling operations and the gradients of slopes of the embankments. For space-related reasons, it was impossible to substantially change the layout in the area of the portal and shift the tunnel service building structure. For that reason, the backfill was terminated at the level of the tunnel vault crown and the eastern side of the tunnel adjacent to the service building was left completely exposed. The aesthetic concept of the cladding of the exposed tunnel side in the Krušné Mountains landscape is shown in Fig. 6. The lining under the basalt cladding is in water retaining concrete.

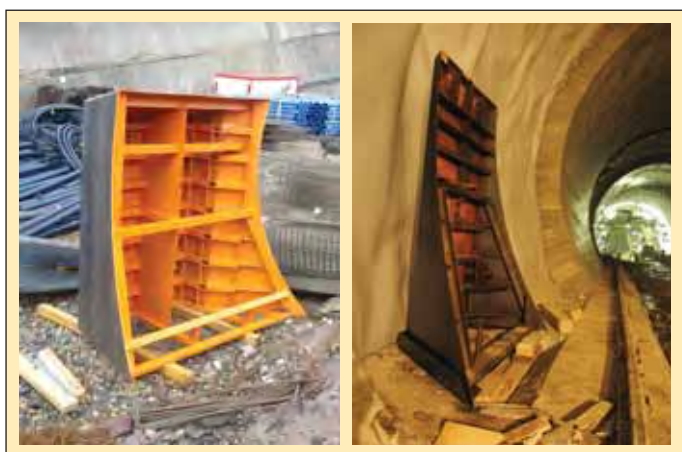
Obr. 7 Bednění původního (vlevo) a optimalizovaného (vpravo) tvaru výklenku čištění drenáže

Fig. 7 Formwork for the original shape (left) and optimised shape (right) of the drainage cleaning recess

Jako příklad optimalizace tvaru výklenků lze uvést výklenky čištění drenáže u tunelů Libouchec a Panenská, které se oba nacházejí na dálnici D8 před hranicí se SRN. S předstihem projektovaný tunel Panenská měl výklenky čištění drenáže navržené pro původní průměr šachet podle zadávací dokumentace, a to zásadním způsobem ovlivnilo hloubku výklenku. Při projednávání technického řešení tunelu Libouchec se podařilo díky pozitivnímu přístupu investora zmenšit průměr šachet na čištění boční tunelové drenáže na pouhých 500 mm při hloubce šachet 1,5 m. Výsledný efekt ukazuje obr. 7, na kterém je vlevo bednění výklenku na tunelu Panenská, vpravo optimalizovaný tvar pro tunel Libouchec. Pro betonáž kratšího tunelu zhotovitel neváhal nechat vyrobit nové bednění formy výklenků.

As an example of the optimisation of the shape of recesses, we can mention the drainage cleaning recesses in the Libouchec and Panenská tunnels, which are both found on the D8 motorway, before the border with the FRG. The drainage cleaning recesses for the Panenská tunnel, which was designed in an advance, were designed for the original diameter of the manholes given by the tender documents, which fact principally affected the depth of the recess. When the technical solution for the Libouchec tunnel was being negotiated, the side drainage cleaning manhole diameter was successfully reduced to a mere 500mm at the manhole depth of 1.5m, thanks to the owner's positive attitude. The resultant effect is shown in Fig. 7, in which the formwork for the Panenská tunnel is on the left side and the optimised formwork shape

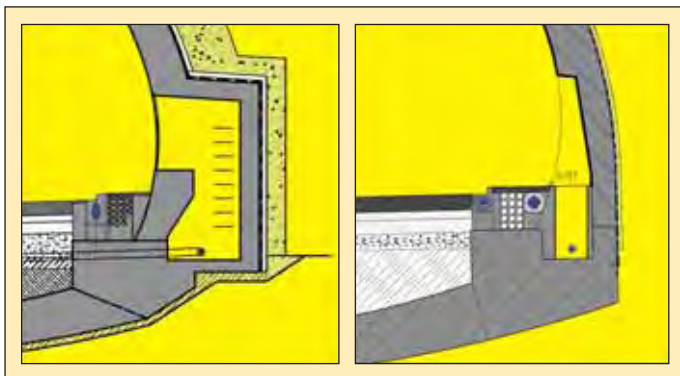
Obr. 8 Optimalizace tvaru výklenku u tunelů SOKP 513
Fig. 8 Optimisation of the recess shape in the PCCR 513 tunnels

When working on the detailed design for tunnels on construction lot 513 of the Prague City Circle Road, the designer used the experience obtained on the Libouchec tunnel and, after numerous discussions with the project owner and future operator, he managed to push through the reduction of the diameter of side drainage cleaning manholes from 800mm to 600mm. The result of this optimisation was even more visible than that in the case of the tunnels on the D8 motorway. The main concern of the owner was the future maintenance if the diameter is reduced. The experience gained during operation shows that the diameter of a manhole causes no problems during the drainage cleaning. The crucial role is played by regular maintenance of the drainage system, first of all during the first years after the tunnel commissioning, when washing out of fines from the ground mass and the shotcrete primary lining takes place. It turned out during the initial cleaning after the tunnel commissioning that the thickness of sediments in the pipeline can be significant. The reduction in the depth of manholes contributed to dispelling the owner's concerns. The PCCR 513 tunnels are found on two reverse curves with the transverse incline of the roadway of 2.5%. The designer, using experience from abroad, proposed that the entire tunnel profile be rotated proportionally to the transverse incline of the roadway, thus he saved about 15cm of the manhole depth compared to the original design and, first of all, simplified the access to drains, which fact plays crucial role during regular cleaning of the drains. In the case of a non-rotated profile, at the triple-lane tunnel width of 14.5m and even 18m width in the case of the quadruple-lane tunnel, the transverse incline significantly affects the geometric design on the tunnel side, thus also the depth of drains under the pavement surface. Reducing the manhole diameter and using a rebated rear wall of the recess (again according to a foreign model) led to such reducing of the drainage cleaning recess dimensions that the structure did not reach the external side of the cut-and-cover lining. The importance of optimising the shape of the recess is obvious in Fig. 8, where

the structure shape required in tender documents is compared with the shape according to the detailed design. The same shape of the drainage cleaning recess was even used for fire hydrant recesses. This use was possible owing to a modern tunnel hydrant design with the outlet types A and B found above one another, perpendicular to the tunnel centre line. This improvement led to further simplifying of the formwork for the final lining. This shape of recesses, which was developed on the basis of the need for simplifying the formwork for cut-and-cover tunnels, was eventually used even in mined tunnel sections of the tunnels on construction lot 513.

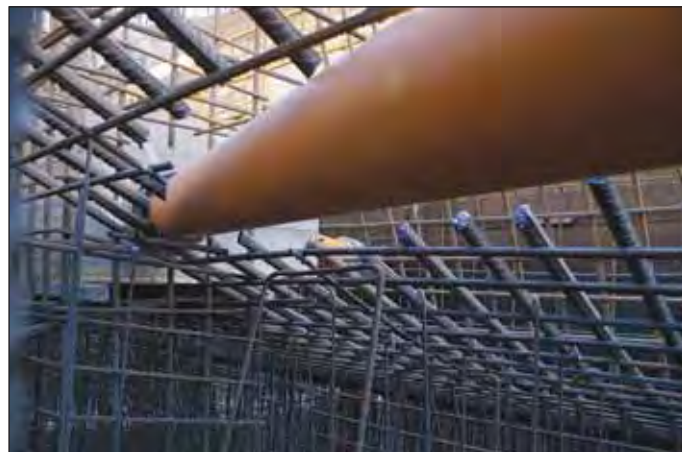
Obr. 9 Přerušování výztuže při průchodu drenáže ostěním
Fig. 9 Cutting out of reinforcement bars for the passage of drainage through the lining

Naopak negativní dopad do konstrukčního řešení tunelového ostění měly požadavky na vedení drenáží. Zatímco v ražené části tunelu probíhá tunelová drenáž podél patky ostění přímo, u hloubeného tunelu zabíhá kvůli tvaru rubu ostění tunelu do výklenku na čištění drenáže a následně vybíhá opět za rub ostění. Úhel odbočení hraje významnou roli z hlediska konstrukčních úprav výztuže ostění. Zatímco na tunelu Libouchec probíhalo odbočení pod úhlem 30°, v případě tunelů stavby SOKP 513 požadoval investor provést odbočení pod úhlem pouhých 15° s ohledem na lepší možnost revize a čištění drenážního potrubí. Zdánlivě ideální řešení z hlediska vodářského se negativně promítlo do konstrukčního řešení z hlediska stavebního. Prodloužení úseku, kde drenážní trubka prochází patou tunelu, i nepříznivý úhel drenáže k ostění ovlivnily provádění výztuže na úseku délky přes 3 m (viz obr. 9). Příklad ukazuje nutnost hledání kompromisů při nalezení optimálního technického řešení a posuzování konkrétních detailů z pohledu všech zúčastněných profesí.

Conversely, requirements for the alignment of drains had a negative effect on the tunnel lining. While in a mined part of a tunnel the tunnel drainage runs directly along the tunnel footings, it diverts to the drainage cleaning recess and subsequently returns beyond the external surface of the lining in the case of cut-and-cover tunnels. The diversion angle plays an important role in terms of structural changes in the reinforcement of the lining. While the diversion angle was 30° in the Libouchec tunnel, the PCCR 513 project owner required the diversion to be only at 15° so that inspections and cleaning of drains were easier to perform. The solution, which was seemingly ideal from hydraulic engineer's point of view, negatively projected itself into the design of the tunnel structure. The extension of the section in which the drainage pipe runs through the tunnel footing and the unfavourable angle between the drain and the lining affected the reinforcement placing operation within an over 3m long section (see Fig. 9). This example shows how necessary it is to seek compromises in searching for an optimum technical solution and assessing particular details from points of view of all professions collaborating on the design.

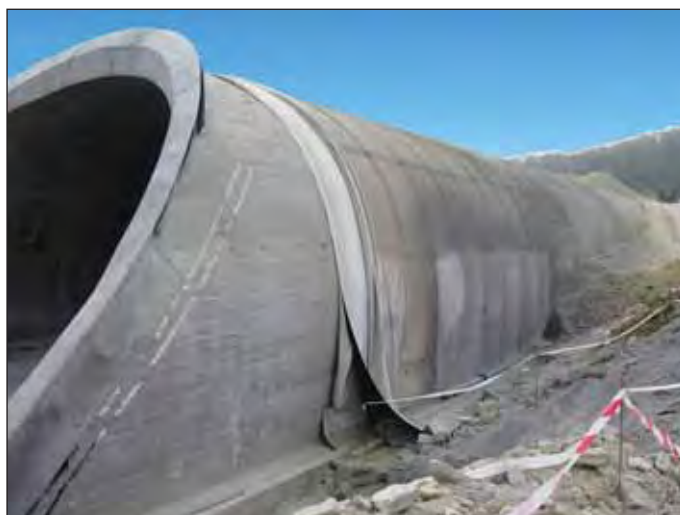
Obr. 10 Ochrana hydroizolace stříkaným betonem
Fig. 10 Protection of the waterproofing with shotcrete

Při výstavbě tunelů stavby SOKP 513 navrhoval projektant zadávací dokumentace ochranu hydroizolační fólie pomocí stříkaného betonu. Jedná se o spolehlivý způsob, který byl použit např. při výstavbě tunelu Sitina v Bratislavě (viz obr. 10). Jeho použití však v případě tunelů SOKP 513 narazilo na prostorové poměry ve stavební jámě. Omezený prostor mezi stěnou jámy a ostěním tunelu technicky neumožňoval nástřik betonu provést. Zhotovitel SKANSKA BS proto společně s projektantem RDS hledali alternativní řešení, které by zohlednilo zvýšené riziko poškození fólie při manipulaci mechanismů ve stísněných poměrech jámy. Ochrana fólie pouze geotextilií v tomto případě nezaručovala bezchybné provádění prací. Původně navrhovaný stříkaný beton po řadě diskusí nahradily nakonec pásy recyklátu. Zhotovitel nejprve použil na kratším 70 m dlouhém přesypaném tunelu pásy z recyklované pryže ELTEC GR 850 FS tloušťky 20 mm. Trvanlivost i odolnost pásů proti mechanickému poškození dokladovaly atesty výrobku prováděné v souvislosti s jeho použitím pod pražci na železnici. Instalace na ostění tunelu probíhala bez větších problémů a výrobcem dokladované mechanické vlastnosti materiálu dávaly záruku dobrého výsledku (viz obr. 11). Komplikace přišly v okamžiku, kdy je nikdo nečekal, a jak se později ukázalo, souvisely s klimatickými podmínkami. Paradoxně se jednalo o počasí pro provádění izolačních prací optimální. Při osvitu slunečními paprsky se díky černé barvě materiál začal rychle zahřívat a následně měknout. Vlastní vahou tak došlo k protažení a nežádoucímu zvlnění. Svou roli hrál i tvar tunelu, jehož boky byly svislé a pásy nebyly k ostění nijak upevněny. I přes určitou komplikaci při provádění se podařilo zpětně zásypy zvládnout a v dnešní době je již tunel v celém rozsahu zasypán (viz obr. 12). Získaná zkušenost byla pro účastníky výstavby cenným poučením a pro ochranu izolace přes 170 m dlouhých úseků na portálu Komořany a 85 m dlouhých úseků na portálu Cholupice již zhotovitel použil recyklát S-FOAM, který i při zahřátí své mechanické vlastnosti zásadně neměnil.

Regarding the tunnels on the PCCR lot 513, the designer for the tender documents proposed protecting the waterproofing membrane by a shotcrete layer. This reliable method was used before, for example during the construction of the Sitina tunnel in Bratislava. (see Fig. 10). The application of this method to the PCCR 513 tunnels was found impossible due to the lack of space in the construction trench. Owing to the constricted space between the side of the trench and the tunnel lining, the application of shotcrete was technically impossible. The contractor, SKANSKA BS, together with the designer, for that reason sought an alternative solution which would allow for the increased risk of damaging the membrane by equipment moving in the constrained conditions of the construction trench. Protecting the membrane only by geotextile in this case did not guarantee flawless execution of the works. The originally designed shotcrete was, after numerous discussions, replaced by sheets of recycled rubber. First, the contractor used 20mm thick ELTEC GR 850 FS recycled rubber sheets on the shorter, 70m long false tunnel. Durability and resistance of the sheets against mechanical damage were documented by certificates which had been issued in the connection with testing of this product for its use under sleepers on rail tracks. The application to a tunnel lining did not encounter bigger problems and the mechanical properties of the material declared by the manufacturer gave a guarantee of a good result (see Fig. 11). Complications arose at the moment when nobody expected them. As it turned out later, they were associated with climatic conditions. Paradoxically, the weather was optimal for the application of a waterproofing membrane. When exposed to the sun light, owing to its black colour, the cladding material quickly started to heat up and subsequently to soften. Then it got elongated by its own weight and undesirably undulated.

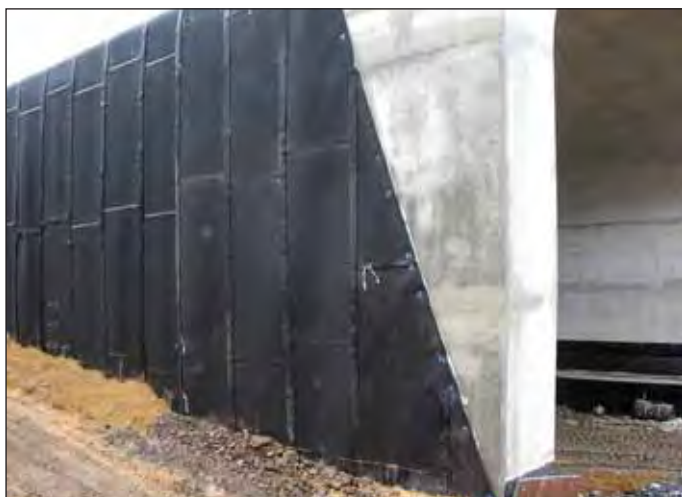
Obr. 11 Ochrana hydroizolace recyklátem pryže ELTEC
Fig. 11 Protection of the waterproofing with ELTEC recycled rubber plates

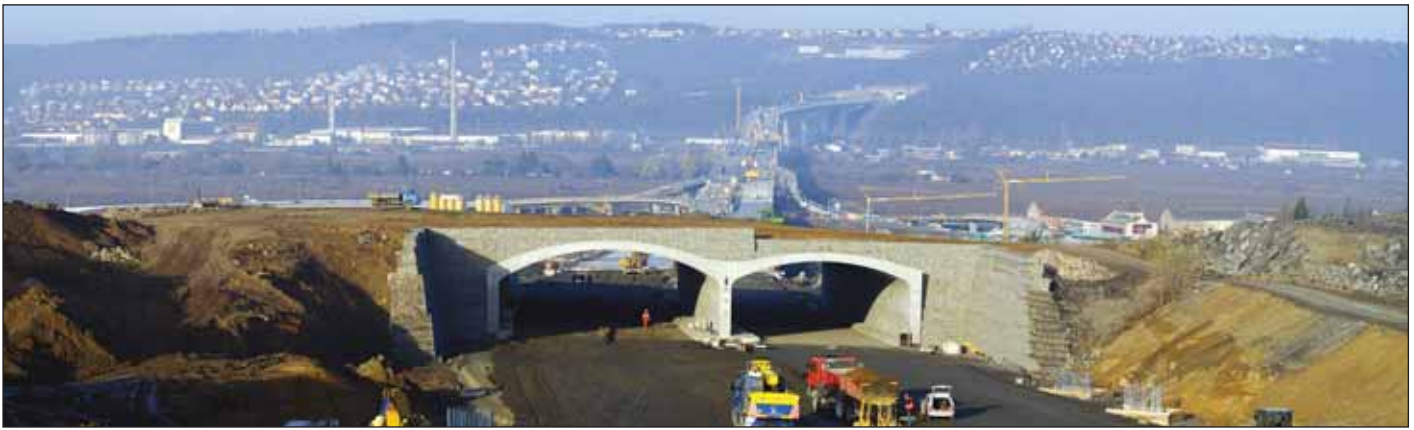
Obr. 12 Kompletní zásyp hloubeného tunelu
Fig. 12 Complete backfill of a cut-and-cover tunnel

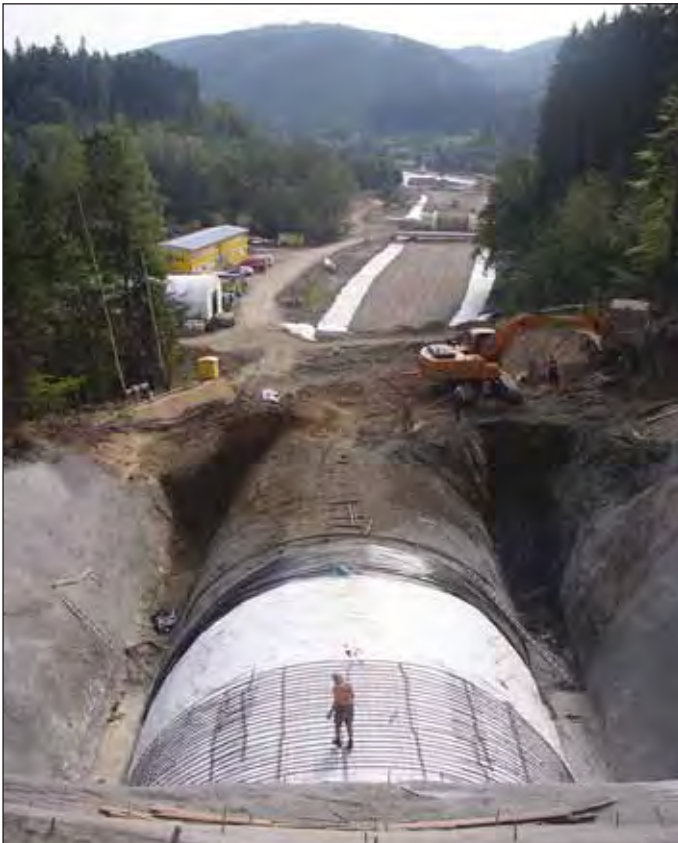
Obr. 13 Tvarování horniny do profilu klenby
Fig. 13 Moulding of ground into the shape of a vault

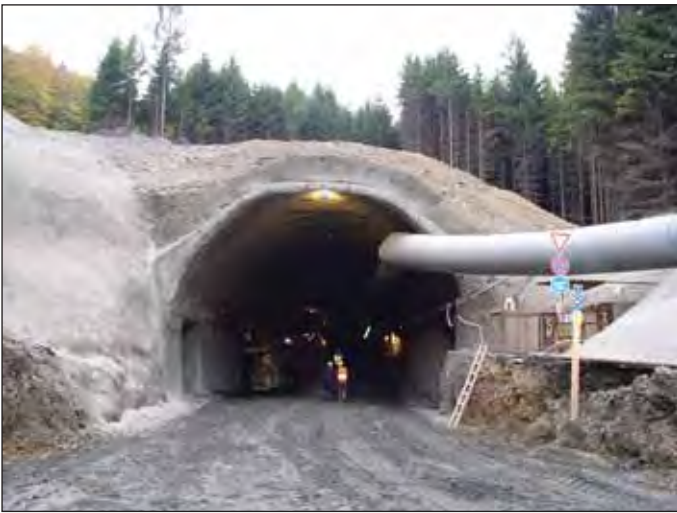
Obr. 14 Ražba tunelu Malá Huba pod provizorní klenbou
Fig. 14 Driving the Malá Huba tunnel under the temporary vault

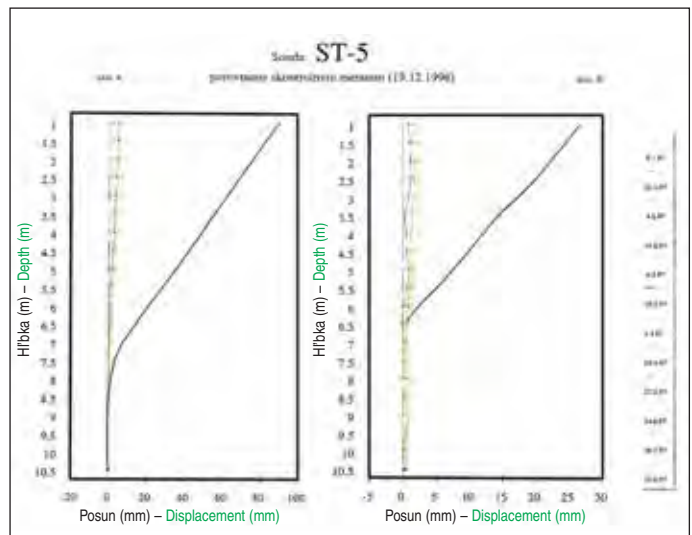
Obr. 15 Průběh deformace podzemní stěny po aktivaci sesuvu
Fig. 15 Diaphragm walls deformation curve after the landslide activation

The other example shows the possibility of using this method for stabilising a slope of the construction trench. The construction in question is the eastern portal of the Branisko motorway tunnel in Slovakia. A significant volume of ground was removed from the toe of a slope of the Branisko mountain range in the area of the portal when an exploratory gallery was being driven and the construction trench for driving of the tunnel itself was being excavated. Anchored diaphragm walls were

designed to protect the construction of the cut-and-cover tunnel. Enormous rains were encountered during the construction trench deepening operations. They saturated the ground mass above the construction trench. Water seeped down to the base of the soil cover, reaching even the weathered layer of the bedrock. The slope above the tunnel started slowly but continuously to move. It had to be quickly stabilised because it would have threatened the construction trench for the tunnel in the case of a landslide. Apart from surface drains and drainage wells, it was necessary as fast as possible to apply a surcharge to the toe of the slope. An inclinometer installed in the diaphragm wall at the instable slope had already shown that the wall was broken, there was therefore little time to waste (see Fig. 15). Because of the new situation, further cutting off of the slope toe in the cut-and-cover tunnel location was ruled out. The work on moulding of the terrain into the vault shape started immediately in the location of the southern tunnel tube. Concrete casting started at the beginning of December. It was seriously complicated by climatic conditions, with temperatures dropping under -15°C . Concrete was placed under the protection of tarpaulins and hot air was blown underneath (see Fig. 16). The 4975m long tunnel was built as a single-tube structure, but there was a short length of the other tunnel tube prepared at the eastern portal, in front of the mouth of the exploratory gallery following the alignment of the future northern tunnel tube. It was formed by a precast vault placed on foundation footings, which were underpinned by micropiles (see Fig. 17). The structure consisted only of two precast elements, structurally acting as a triple-hinged arch. Both the cast-in-place and precast vaults allowed expedited backfilling so that the surcharge to the toe of the slope could be applied and the commencing landslide be intercepted. The slope movements never appeared again during the excavation under the southern tunnel tube vault. Currently, bids have been invited to carry out the design for issuance of the zoning and planning decision for the second tunnel tube. Owing to the implemented measures, the future contractor will not have to reopen the problematic area of the instable slope at the eastern portal. Fig. 18 shows the two vault structures and the front end gabion wall, which made an increase in the backfill volume possible, owing to which the passive area of a potential landslide was surcharged.

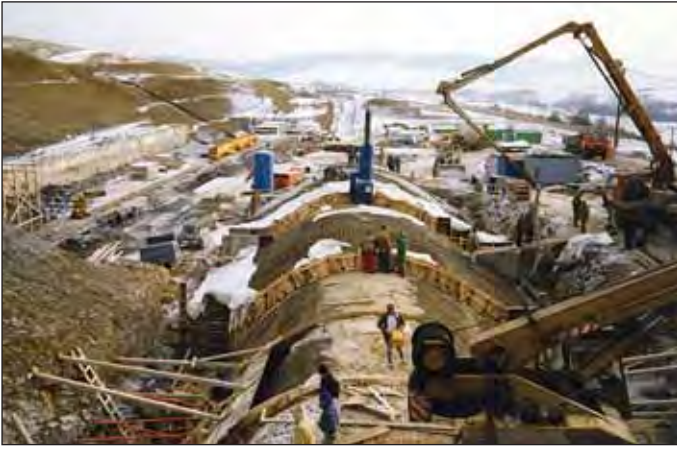
Obr. 16 Klimatické poměry při betonáži želvy na tunelu Branisko
Fig. 16 Climatic conditions during the casting of the Branisko tunnel tortoise shell

Další příklad ukazuje možnost využití této metody ke stabilizaci svahu stavební jámy. Jedná se o východní portál dálničního tunelu Branisko na Slovensku. V oblasti portálu došlo v souvislosti s ražbou průzkumné stoly i s hloubením stavební jámy pro ražbu vlastního tunelu k odtěžení značného množství horniny v patě svahu pohoří Branisko. Hloubený tunel měl být prováděn po ochranou kotvených podzemních stěn. Během prací na prohlubování stavební jámy hloubeného tunelu došlo k enormním deštům a zvodnění horninového masivu nad stavební jámou. Voda prosakovala až na bázi pokrývá a zasahovala i zvětralé polohy skalního podkladu. Svah nad tunelem se dal do pomalého, ale dlouhodobého pohybu a bylo nutné urychleně provést jeho stabilizaci, neboť v případě sesuvu přímo ohrožoval stavební jámu tunelu. Kromě povrchových drénů a odvodňovacích vrtů bylo nutné co nejrychleji zpětně přitížit patu svahu. Inklinometr osazený do podzemní stěny u nestabilního svahu již ukazoval její přelomení a nebylo času nazbyt (viz obr. 15). Další odtěžování paty svahu v místě hloubených tunelů vzniklá situace vylučovala. V místě jižního tunelu bylo okamžitě započato s úpravou terénu do tvaru klenby. Betonáž začala počátkem prosince a značně ji komplikovaly klimatické podmínky, kdy teplota klesala pod $-15\text{ }^{\circ}\text{C}$. Betonáž klenby probíhala pod plachtami, pod které byl vhnán

horký vzduch (viz obr. 16). Tunel délky 4975 m byl prováděn jako jednotroubový, ale u východního portálu již byl před ústím průzkumné štoly, která je vedena v trase budoucího severního tunelu, připraven zárodek druhé tunelové trouby, tvořený prefabrikovanou klenbou osazenou na základových pasech podchycených mikropilotami (viz obr. 17). Konstrukci tvořily pouze dva prefabrikované dílce a staticky se jednalo o tříkloubový oblouk. Monolitická i prefabrikovaná klenba umožnily urychlené provedení zásypů, které zajistily přitížení paty svahu a zastavily počínající sesuv. Při ražbě pod klenbou jižního tunelu se již svahové posuny neprojevovaly. V současné době je vypsáno výběrové řízení na projekt pro územní rozhodnutí výstavby druhé trouby tunelu. Budoucí zhotovitel díky provedeným opatřením již nebude muset znovu otevírat problematickou oblast nestabilního svahu východního portálu. Na obr. 18 jsou znázorněny obě klenbové konstrukce a čelní gabionová zeď, která umožnila zvýšit objem zásypů a přitížit tak pasivní oblast potenciálního svahového sesuvu.

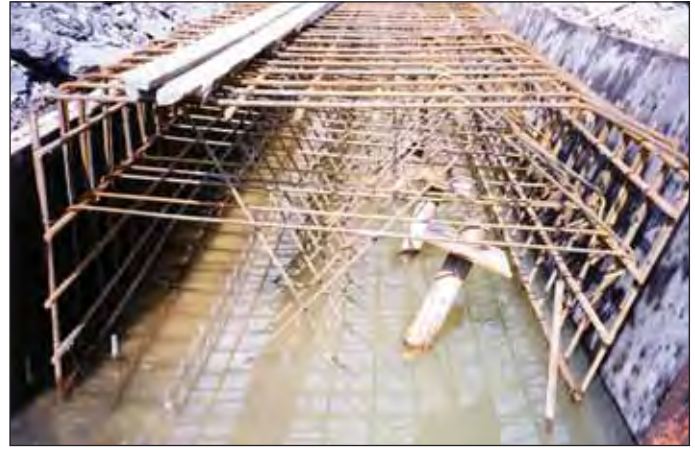
Obr. 17 Podchycení základových patek prefabrikované klenby
Fig. 17 Underpinning of footings of the precast vault

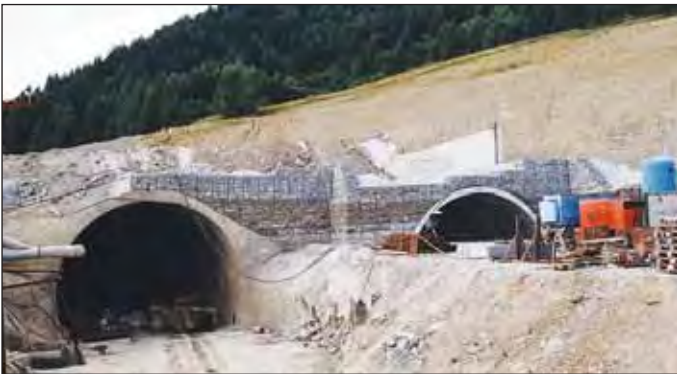
Obr. 18 Přitížení paty svahu východního portálu tunelu Branisko
Fig. 18 Surcharging of the toe of the slope at the eastern portal of the Branisko tunnel
