VOTICKÝ ŽELEZNIČNÍ TUNEL – TECHNICKÉ ŘEŠENÍ A ZKUŠENOSTI Z VÝSTAVBY

VOTICE RAIL TUNNEL – TECHNICAL SOLUTION AND EXPERIENCE FROM CONSTRUCTION

LIBOR MAŘÍK

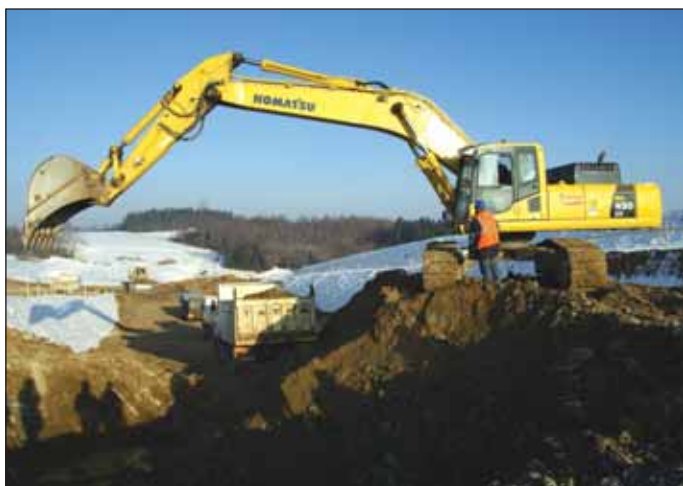
Obr. 1 Zahájení těžení jámy (01/2010)
Fig. 1 Commencement of pit excavation (01/2010)

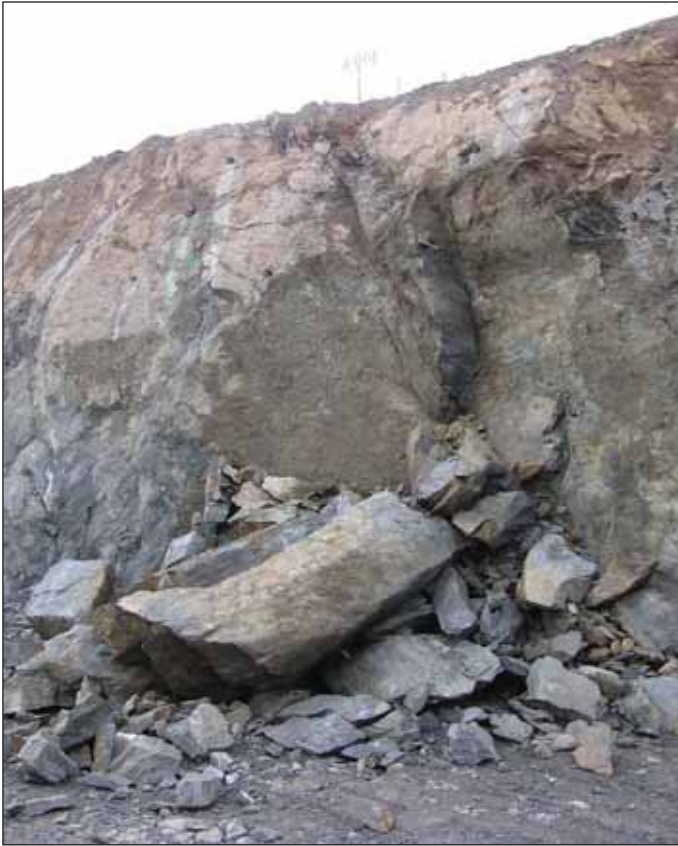
Obr. 2 Uvolněné skalní bloky (04/2010)
Fig. 2 Loosened rock blocks (04/2010)

Wedge-shaped blocks of rock fell from time to time from the construction trench sides during the process of deepening the excavation in the sections where eluvial layers virtually did not exist and the rock mass reached up to the terrain surface, owing to the orientation of discontinuity surfaces to the inclination of the construction trench slopes. The rock fragmentation degree varied, depending on the direction of discontinuities, from small blocks up to block sizes in the order of metres. Apart from the formation of “overbreaks”, this situation led to undesired increasing of the earthwork volume and, first of all, threatening of the safety of workers. The geologist employed by the author of the detailed design conducted informative measurements of the dip and orientation of discontinuity surfaces on the exposed sides of the construction trench. Results of this measurement proved that the rock mass is fissured along many surfaces and in many directions and it is possible to state that the massif slides along these surfaces toward the construction trench on the western slopes, whilst the fissures dip into the construction trench slope on the eastern side. Both situations were dangerous in terms of the stability of the slope. On the western slope, sliding wedge-shaped blocks caused the expansion of local surface instabilities

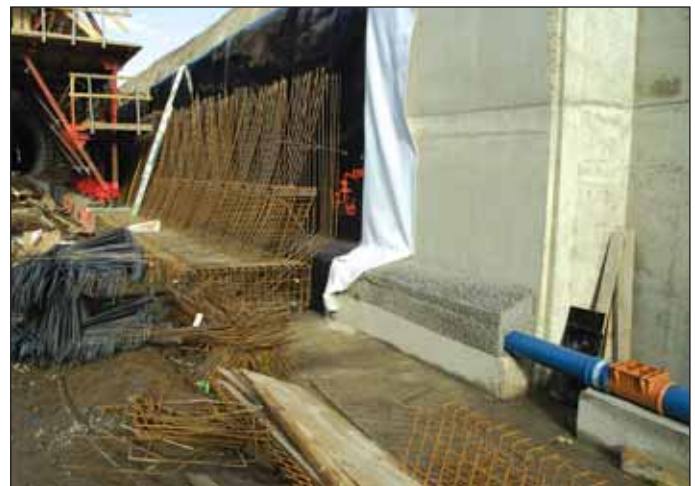
Obr. 3 Drenáž, separační fólie a výztuž
Fig. 3 Drainage, separation membrane and reinforcement

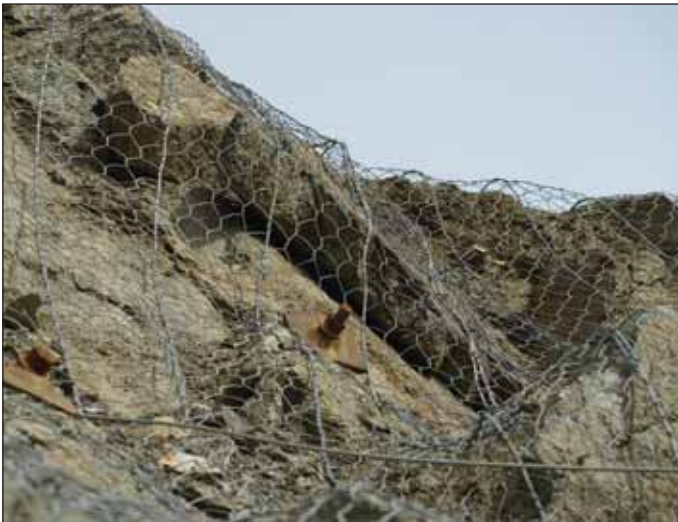
Obr. 5 Ochranné síť
Fig. 5 Protective mesh

Poslední metr kotvy byl ponechán volný, aby bylo možné kotvu aktivovat momentovým klíčem na hodnotu předpětí 50 kN. Vnesená normálová síla zvýšila tření na puklině a zamezila vypadnutí klínu horniny. Tento systém kotvení se v praxi osvědčil a minimalizoval výrazným způsobem vypadávání klínů horniny. Další změnou oproti původnímu návrhu byla receptura zálivky kotev. Původní cementová zálivka umožňovala předepnutí až po čase v řádu dnů. Do té doby však již došlo k zásadnímu rozvolnění horniny po predisponovaných plochách a rozpadu povrchové vrstvy horniny až na hloubku přes 1 m. Abychom tomuto způsobu porušení zabránili, byla pro zálivku použita směs EKOMENT RT umožňující aktivaci kotvy po 24 až 30 hodinách. Systémové kotvení bylo v projektové dokumentaci navrženo v ortogonálním rastru 2,5x2,5 m se šachovnicovým uspořádáním, takže vzájemná vzdálenost kotev nepřesahovala 1,25 m. V porovnání s původním způsobem kotvení došlo k vypadnutí bloku jen v několika případech a uvolněnou část horniny okamžitě zachytila vysokopevnostní dvouzákrutová síť (obr. 5).

discontinuities gradually started to open, releasing a block of rock during several days. Taking into consideration the negative experience, the designer proposed another system of anchoring for the trial section. The 6 m long all-thread bars were inserted into EKOMENT RT grout along the length of 5 m. The last metre of the anchor was left free so that the anchor could be activated with a torque wrench to achieve the pre-tension value of 50 kN. The normal force introduced into the rock mass increased friction on a crack and prevented the rock wedge from slipping out. This anchoring system acquitted itself in practice and significantly minimised slipping of rock blocks out. Another deviation from the original proposal was in the formula for the anchoring grout. The original cement grout allowed the pre-tensioning to be carried out only after a time in the order of days. But during this time the rock got significantly loosened along predisposed planes and the surface layer of the rock disintegrated to the depth even exceeding 1 m. With the aim of preventing this way of disturbing, we used EKOMENT RT grout, allowing the activation of anchors after 24 to 30 hours. The anchoring system was proposed in the design to be carried out in an orthogonal grid 2.5 m x 2.5 m, in a diamond pattern, which means that the spacing between anchors did not exceed 1.25 m. In comparison with the original way of anchoring, a rock block slipped out only in several cases and the loosened part of rock was immediately restrained by the high-strength double twisted mesh (see Fig. 5).

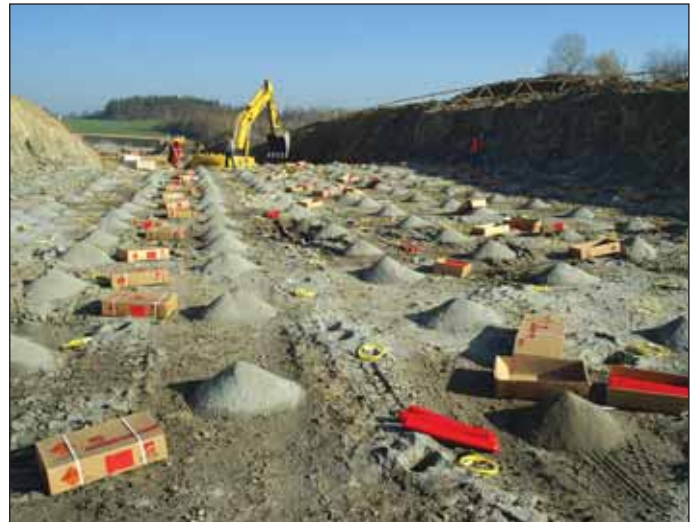
Obr. 6 Rozpojování trhavinami (04/2010)
Fig. 6 Disintegration by means of explosives (04/2010)

Velmi diskutovaným tématem bylo rozpojování horniny a vliv trhacích prací na porušení horninového masivu a přesnost dodržení projektovaného tvaru stavební jámy. Zpočátku prováděné trhací práce vedly k silnému rozpukání svahů stavební jámy a podpořily rozpad po přirozených, tektonicky podmíněných diskontinuitách. Seismické účinky trhacích prací jsou pravděpodobně jedním z negativních faktorů, který urychlil rozpad povrchových vrstev horniny. V průběhu času zhotovitel upravoval vrtná schémata a časování roznětu tak, aby se tyto účinky minimalizovaly (obr. 6). V souvislosti s minimalizací seismických účinků a zejména minimalizace nadvýrubů byla nasazena skalní fréza Vermeer T1255 s motorem Caterpillar o výkonu 447 kW (obr. 7). Vzhledem k pevnosti a abrazivitě granodioritů ji bylo možné použít pouze ve vyšších partiích stavební jámy. I tam však vykonala neocenitelné služby v oblasti vjezdového portálu v místě, kde trasu tunelu křížuje vedení vysokého napětí. Vzhledem ke složitým majetko-právním vztahům se nepodařilo v požadovaném čase zařídit přeložku vedení a bez nasazení frézy by se práce v této oblasti musely přerušit. Důvodem je situování sloupu vysokého napětí přímo na hraně stavební jámy (obr. 8). Pomocí frézy došlo k odtěžení cca 5 m horniny a po zahloubení na tuto úroveň je již možno pod vedením použít pro rozpojování trhací práce.

A highly discussed topic was the process of rock disintegration and the impact of blasting operations on the disturbance to the rock mass and the accuracy adhering to the design shape of the construction trench. The blasting operations which were carried out at the beginning led to heavy cracking of the construction trench slopes and contributed to the disintegration along natural, tectonically conditioned, discontinuities. Seismic effects induced by blasting operations are probably one of the main negative factors which accelerated the disintegration of the surface layers of the rock. During the time, the contractor adjusted the drill patterns and blast timing with the aim of minimising these effects (see Fig. 6). A Vermeer T1255 rock trencher with a 447 kW Caterpillar engine (see Fig. 7) was applied in the context of the minimisation of seismic effects and, first of all, minimisation of overbreaks. Because of the strength and abrasivity of the granodiorite, this machine was suitable only for the higher parts of the construction trench. Nevertheless, it provided an invaluable service, especially in the area of the entrance portal, in the location where the tunnel route is crossed over by a high-tension line. Because of complicated ownership relationships the attempts to arrange diverting of the line in the required time failed and the operations in this area would have to be suspended without the application of the trencher. The reason is the fact that a power-transmission pole was located directly at the edge of the construction trench (see Fig. 8). About 5 m thick layer of rock was excavated using the trencher. After the excavation reached this level, it started to be possible to disintegrate the rock by blasting.

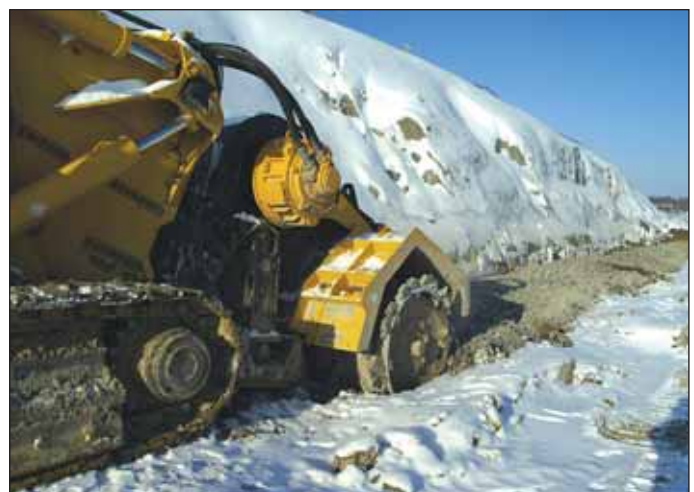
Obr. 7 Skalní fréza
Fig. 7 Rock treacher

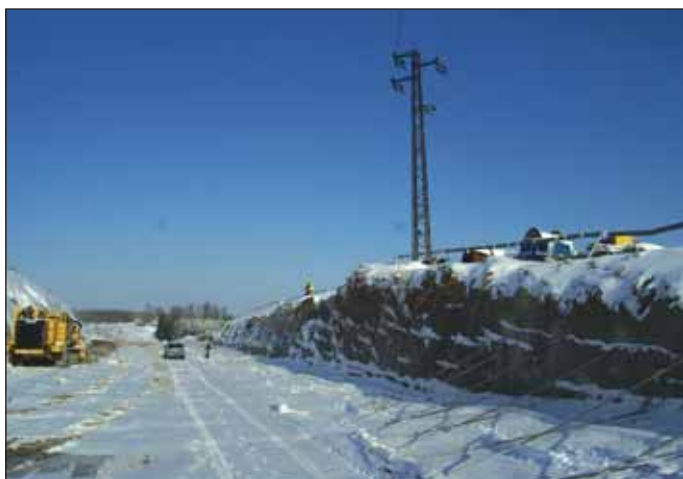
Obr. 8 Stožár VN na hraně jámy
Fig. 8 High-tension line pole at the pit edge

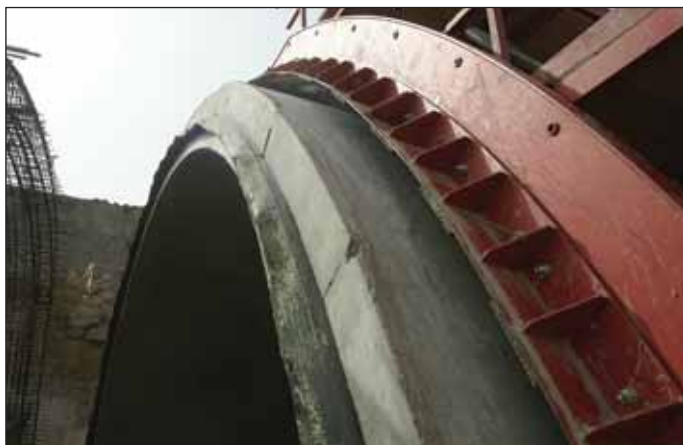
Obr. 10 Spárový pás
Fig. 10 Waterstop

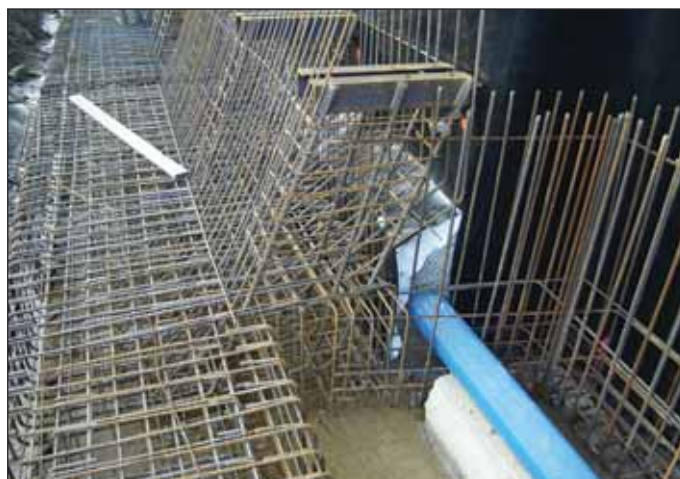
Obr. 9 Boční tunelová drenáž
Fig. 9 Tunnel side drainage

Once the problems about securing the stability of the construction trench had been overcome, it was finally possible to start the work on the drainage system installation of the concrete reinforcement and casting of the final lining. Even though this is the case of a cut-and-cover tunnel, some elements used during the construction are rather known from the construction of final linings of mined sections of tunnels. One of them is the system of side drains along tunnels. Taking into consideration the bracing of tunnel sides against the construction trench side, the side drains had to be installed before the casting of footings and the lining vault. Since the packing of the drains at the same time acted as the outer formwork for the tunnel footings, it was necessary to use porous concrete instead of gravel for the packing (see Fig. 9). Because, in contrast with mined sections of tunnels, the reinforcement of footings and tunnel vaults is interconnected in the cut-and-cover tunnel, the drainage had to be

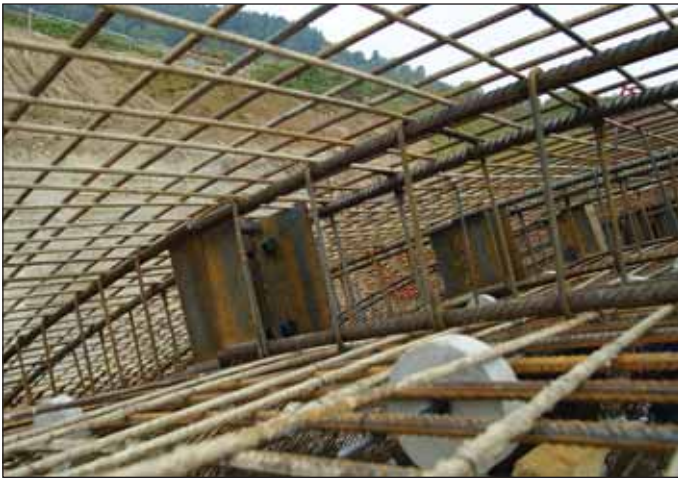
Obr. 11 Stykání rámu samonosné výztuže
Fig. 11 Joining the components of self-supporting girders

což pracovní cyklus dále prodlužuje. U krátkých úseků hloubených tunelů nehraje tato skutečnost tak významnou roli. V případě Votického tunelu s 59 bloky betonáže se již jedná o prodloužení doby výstavby až v řádu měsíců. Na návrh projektanta je proto výztuž tunelu navržena jako samonosná, což je metoda používaná u definitivního ostění ražených úseků tunelů. Navržený způsob vyztužování zcela eliminuje blokování bednění pro montáž výztuže. Formu je možno přesunout ihned po odbednění k již připravené samonosné výztuži a betonáž zahájit ihned po správném geometrickém ustavení bednění. Samonosná výztuž vyžaduje použití tuhých rámu, které tvoří nosnou kostru a na které je pak následně navazována další výztuž (obr. 11). Zhotovitel se rozhodl vyztužení provádět z prutové výztuže. S ohledem na vodonepropustnost ostění a omezení vzniku trhlin je nutno volit menší profily výztuže s menší roztečí prutů.

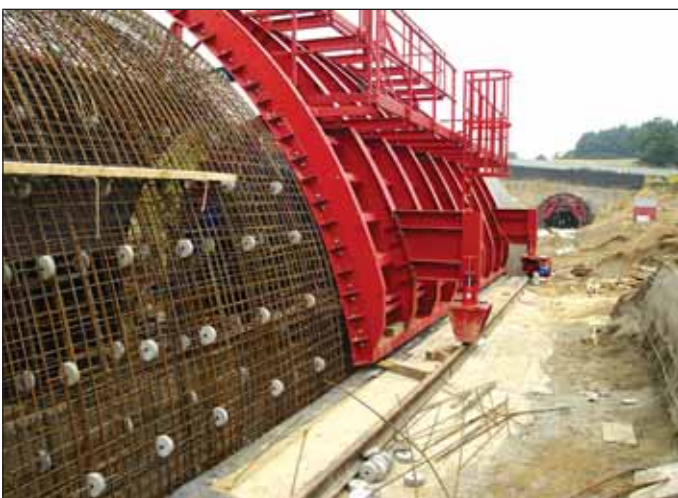
Obr. 12 Vnější bednění
Fig. 12 Outer formwork

A watertight lining requires concrete mix with low generation of hydration heat and good quality, rigid formwork allowing the application of vibrators to be used. The inner formwork consists of a travelling steel gantry with external vibrators

mounted on its jacket. Immersion vibrators can be installed through casting gates in the traveller formwork jacket. The outer shell of the formwork is also formed by a travelling steel structure, which moves on the first bench above the bottom of the construction trench (see Fig. 12). The technical solution proposed by the designer allows a streamlined system to be applied, where the construction trench excavation and slope stabilisation operations are followed by pouring of blinding concrete, installation of drains, casting of footings, installation of reinforcement and casting of the tunnel vault (see Fig. 13). Standard 10 m long concrete casting blocks are designed in C25/30 XC2, XF1 concrete with the permitted water penetration of 35 mm. The portal blocks, which are more exposed and directly influenced by climatic effects, are designed C30/37 XC2, XF3 concrete with the permitted water penetration of 25 mm. After the casting of the vault, the concrete cableways and walkways is cast and the inner equipment of the tunnel is installed. Before the tunnel is opened to traffic, the structure is backfilled and at least a part of the area along the footprint of the new railway route is reinstated.

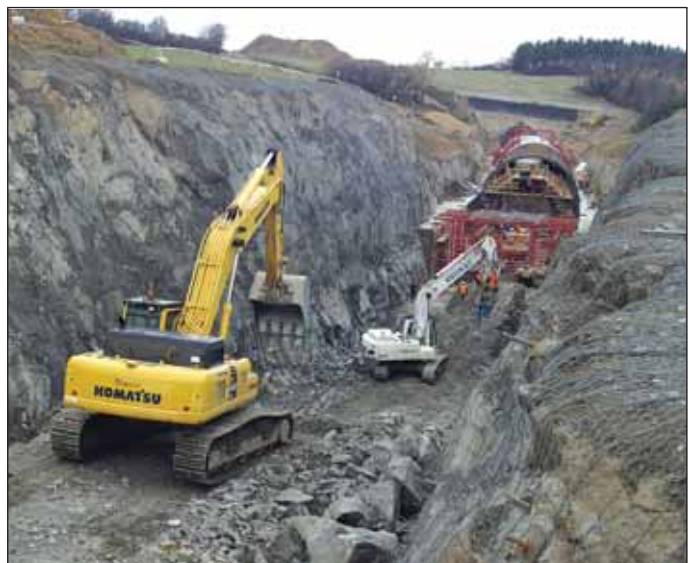
Obr. 13 Proudový způsob výstavby
Fig. 13 Streamlined construction system
