ÚNIKOVÁ ŠACHTA TUNELU BŘEZNO

EMERGENCY ESCAPE SHAFT OF THE BŘEZNO TUNNEL

TOMÁŠ PARÁK, ERMÍN STEHLÍK

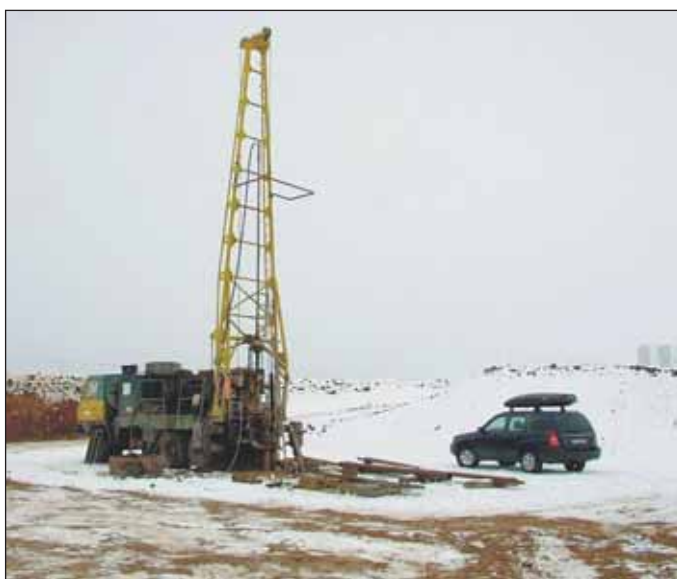
Foto 1 Ověřovací vrt délky 60 m
Photo 1 Drill rig for core borehole

Protože od okamžiku závalu do období zahájení prací v oblasti ovlivněné závalem uplynuly více než dva roky, byl v prostoru budoucí šachty navržen a realizován jeden jádrový vrt hloubky 60 m (foto 1). Hlavním úkolem vrtu bylo ověřit výskyt větších dutin a podzemní vody v okolí zavaleného stroje. Dalším úkolem vrtu bylo objasnit, zda horní a střední uhelná sloj nacházející se pode dnem tunelu není zasažena hornickou činností a nemohla tak přispět ke kolapsu tunelu.

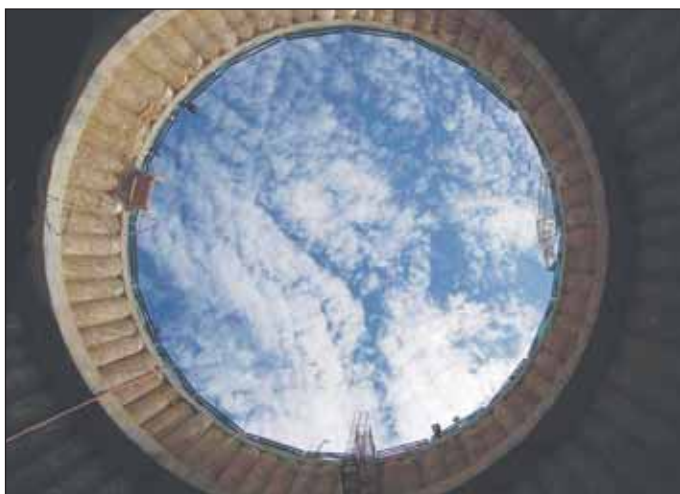
Foto 2 Ukázka výsledku vrtání pilot – pohled ze dna šachty
Photo 2 Completed piles – view from the bottom of the shaft

Přesnost provedení pilot byla velmi dobrá (foto 2) a dosažené odchylky byly v hodnotách pod 1 % z délky pilot, což byl striktní požadavek v realizační dokumentaci. Při betonáži pilot nedošlo k žádným větším spotřebám betonové směsi, což lze přičíst provedeným výplňovým injecktážím.

The drilling accuracy was very good (see Photo 2) and tolerances achieved were in values below 1% of the pile length, which was a strict condition of the design. During pile concreting no large overconsumption of concrete was reported, which could be attributed to the grouting.

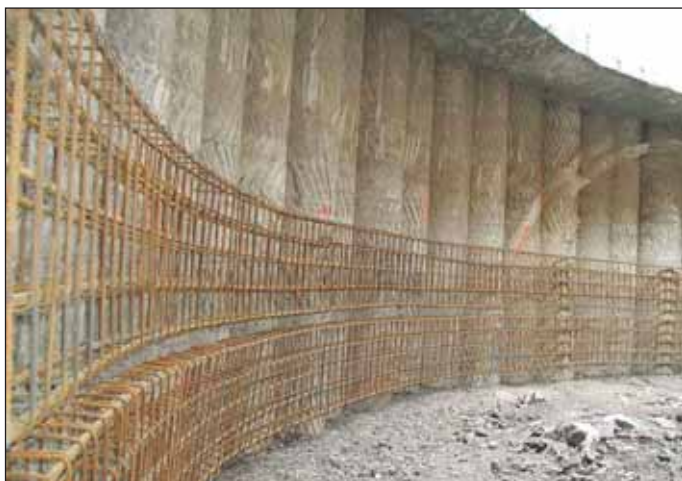
Foto 3 Počátek zřizování ztužujících prstenců 3 m pod převázkou 3
Photo 3 Reinforcing rings below Ring Beam 3

Hloubení šachty a související práce na zřízení převázek a stěn byly zahájeny v dubnu 2006. Po provedení převázky 1 na hlavách pilot se hloubilo po záběrech 5 m až na úroveň převázky 2. Po jejím vybetonování se opět po záběrech 2 m pokračovalo k převázce 3. Vzhledem k dobré dosažené přesnosti vrtání pilot nebylo nutné mezi převázkami 2 a 3 realizovat ztužující prstence ze stříkaného betonu původně předpokládané od úrovně 4 m nad převázkou 3. Jejich realizace začala až v úrovni 3 m pod převázkou 3 a pokračovala až na dno šachty, k horní úrovni převázky 4 (foto 3).

Shaft excavation and related works started in April 2006. After the completion of Ring Beam 1 on the piles' heads the excavation in 5.0 m rounds started, up to the Ring Beam 2 level. After casting the ring beam, the excavation in 2.0 m rounds continued to Ring Beam 3. Thanks to the achieved pile drilling accuracy it was not necessary to install reinforcing shotcrete rings between Ring Beams 2 and 3, originally designed from a level 4.0 m above Ring Beam 3. Reinforcing rings were applied starting from a level 3.0 m below Ring Beam 3 and continued up to the bottom level of the shaft, to the upper level of Ring Beam 4 (see Photo 3).

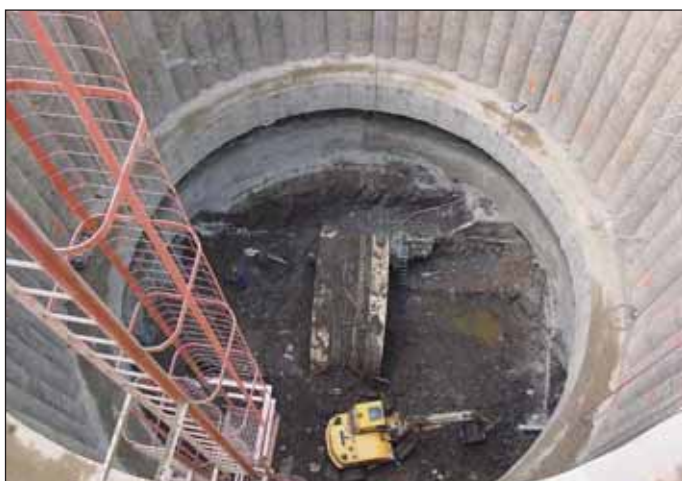
Foto 4 Hloubení šachty v oblasti zavaleného stroje Perforex
Photo 4 Excavation in the vicinity of the buried Perforex machine

Hloubení pod převázkou 3 bylo komplikováno přítomností zavaleného stroje Perforex a zříceného primárního ostění. Bylo nutné postupovat pomalu a nebylo možné použít větší mechanizaci (foto 4).

The excavation below Ring Beam 3 was complicated by the existence of the buried Perforex machine and collapsed lining. It was inevitable to progress slowly and it was not possible to use larger equipment (see Photo 4).

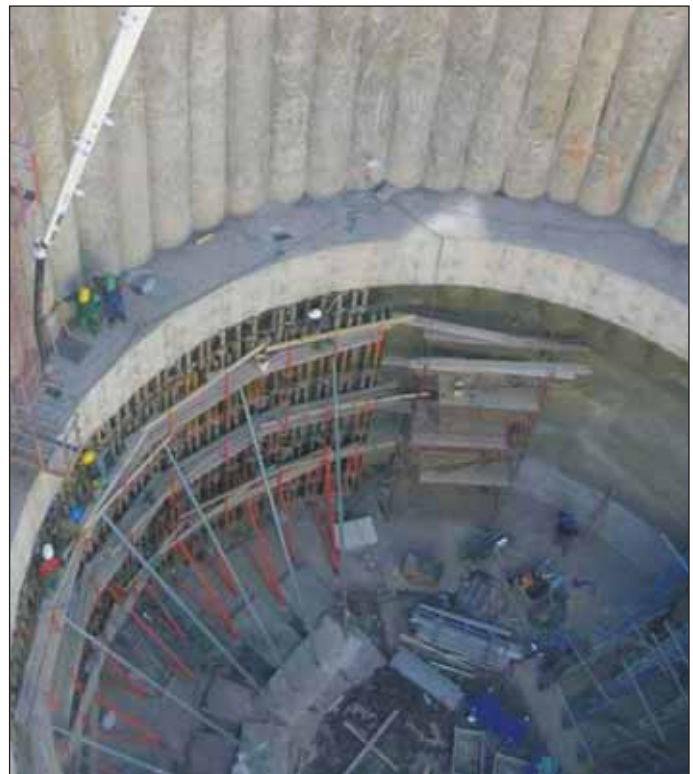
Foto 5 Betonáž ztužující stěny B samohutnícím betonem
Photo 5 Casting of wall B by self-compacted concrete mix

U větší stěny B (foto 5) byla použita technologie samohutňícího betonu a stěna byla vybetonována najednou na celou výšku. Bylo nutné pečlivě navrhnout betonovou směs s potřebnými přísadami tak, aby beton v jednotlivých pracovních záběrech (vrstvách) ve stanoveném čase dosáhl určité pevnosti, která by zaručila požadovaný maximální tlak betonové směsi na bednění. Zároveň však nesmělo dojít k vytvoření pracovní spáry. Po pečlivých přípravách betonáž stěny proběhla bez větších problémů.

For the larger wall B (Photo 5) the technology of self-compacting concrete was used and the wall was cast completely for the whole height. It was important to design the concrete mix with the required additives very carefully in such a way that the concrete strength in prescribed time in particular work rounds (layers) reached the required value, which guaranteed the maximum load of concrete to the formwork. At the same time the occurrence of a cold joint was not allowed. After careful preparatory works the casting passed without major problems.

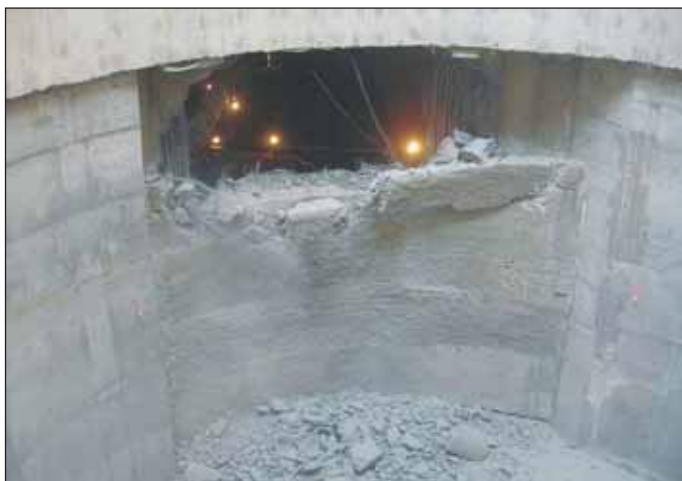
Foto 6 Počátek prorážky tunelu do šachty
Photo 6 Start of the piles demolition for the tunnel opening

Po dokončení betonáže stěn došlo v červenci 2006 k vybourání pilot v prostoru tunelu raženého závalem od portálu u Března (foto 6), druhý otvor pro tunel ražený sekvenční metodou od portálu u Droužkovic byl realizován v říjnu 2006.

After the completion of the wall casting in July 2006, the demolition of the piles for the tunnel mined from the Březno portal through the collapse was executed (Photo 6); the second opening in the shaft for the tunnel mined by the sequential method from the Droužkoviče portal was executed in October 2006.
