NOVÉ TUNELY NA VYSOKORYCHLOSTNÍ TRATI NORIMBERG – INGOLSTADT, ÚSEK „STŘED“

NEW TUNNELS ON THE “MIDDLE” SECTION OF THE NUREMBERG – INGOLSTADT HIGH-SPEED LINE

Mgr. JIŘÍ ZMÍTKO, ILF CONSULTING ENGINEERS, s. r. o.

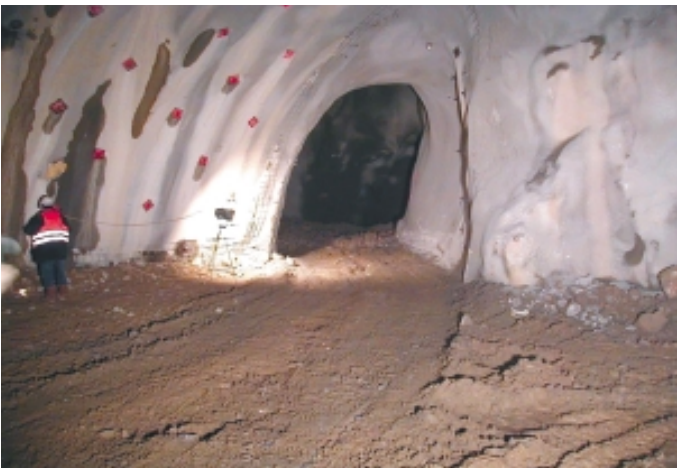
Obr. 2 Jeskyně zastížené během ražby tunelu Irlahüll
Fig. 2 Cavities encountered during the Irlahüll tunnel excavation

The frequent and many times totally unexpected occurrence of cavities whose extent crossed original anticipations resulted in a necessity to carry out a backward detailed verification of their extent. Geophysics application seemed to be the simplest way. The 100 m long tunnel section which the extent and size of the cavities had already been verified in during the excavation was chosen for the purpose of the selection of geophysical measure-

Častý a mnohdy zcela neočekávaný výskyt dutin, jejichž rozsah předčil původní očekávání, vedl k nutnosti zpětného detailního ověření jejich rozsahu. Nejjednodušší se jevílo využití geofyziky. Pro výběr dodavatele geofyzikálních měření byl vybrán 100 m dlouhý úsek tunelu, ve kterém došlo k ověření rozsahu a velikosti dutin již během ražby. Geofyzikální měření však buď nebyla schopna dutiny detekovat vůbec, nebo poskytovala pouze nedostatečné a nejednoznačné výsledky. K detekci dutin proto sloužilo zdlouhavé a pracné předvrtávání plnoprofilových vrtů do dna tunelu. Stejně jako v případě předvrtávání čelby se dokumentovala rychlost vrtání a barva výplachu. Zvláště kritická místa byla prozkoumána jádrovými vrty. Dodatečně práce IG průzkumu značně zpomalily stavbu tunelu.

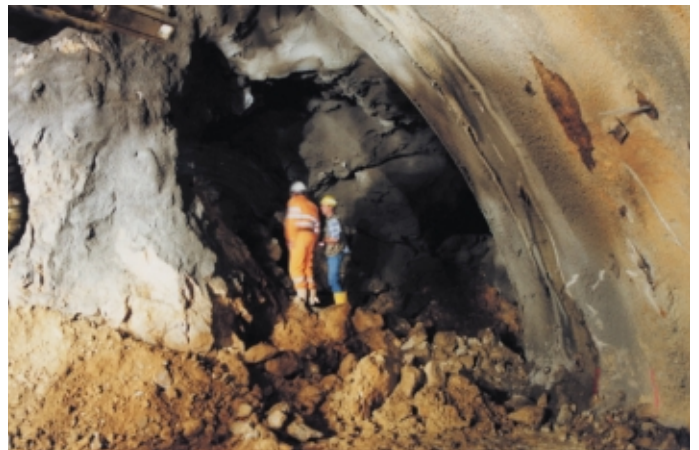
Obr. 3 Kaverny v podzemí Irlahüll
Fig. 3 Caverns in the Irlahüll underground

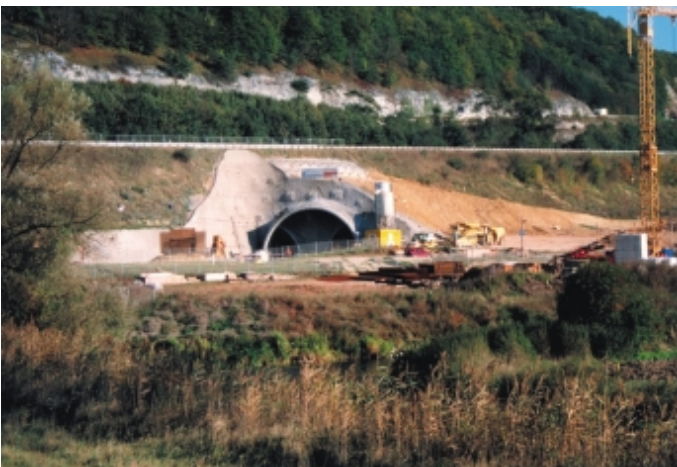
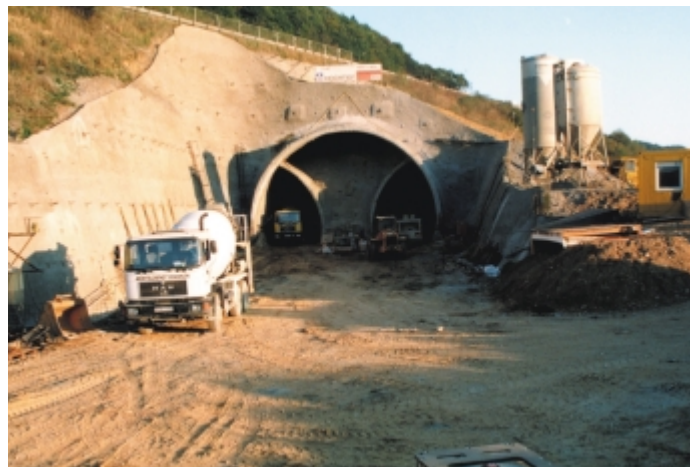
The North portal of the Irlahüll tunnel (see Fig. 4, 5) is situated in a slope under the A9 six-lane motorway. For that reason maximum stability of the excavation had to be secured, and deformations of the cover restricted to a minimum level.

Obr. 4 Pohled na severní portál tunelu Irlahüll
Fig. 4 A view of the Irlahüll tunnel North portal

Obr. 5 Pohled na severní portál tunelu Irlahüll
Fig. 5 A view of the Irlahüll tunnel North portal

Severní portál tunelu Irlahüll (viz obr. 4, 5) je situován ve svahu pod šesti-proudou dálnicí A9. Z tohoto důvodu bylo nutno zajistit maximální stabilitu výrubu a deformace nadloží omezit na minimum.

První fázi prací představovalo přispáný přítěžovacího násypu ke stávajícímu násypu dálnice, z jehož etáží se realizovalo přikotvení části portálového svahu pramencovými kotvami. Vlastní ražba začala pod ochranou v předstihu navrtaného deštníku z mikropilót. V celém úseku pod dálnicí probíhala ražba s vertikálním členěním výrubu a s důrazem na rychlé uzavření dílčích profilů. Díky provedeným opatřením proběhl podchod dálničního tělesa bez vážnějších problémů a bez negativních projevů tunelování na konstrukce v nadloží.

The first phase of the works consisted in adding a stabilising fill to the existing motorway embankment. Anchoring of a part of the portal slope with cable anchors was carried out from the partial levels of the fill. The excavation proper started under the protection of an in-advance-drilled micropile umbrella. A vertical sequence was used for the excavation of the whole section under the motorway, with a stress placed on quick closing of partial profiles. Owing to the measures adopted, the motorway embankment was passed under without any serious problem and without negative manifestations of the tunnelling in the above laying structures.

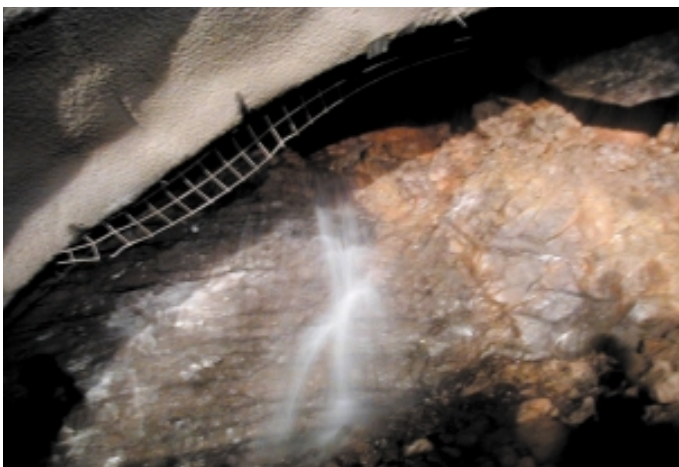
Obr. 6 Podzemní potok na čelbě tunelu Euerwang
Fig. 6 Underground stream at the Eurwang tunnel face

However, the rock quality improved step by step. The only trouble was the open cracks with loamy fill, causing from time to time falling of large blocks of rock from the face and vault. The length of rounds increased with the progressing excavation and distance of the face from the portal, and drill-and-blast started to be used. But a karst cavity appeared unexpectedly at chainage 388.3 m, with a 10 litre/s flow underground stream (Fig. 6). It was peculiar that this karst system was found in grounds which are not subject to karstification and no other demonstration of the karstification was encountered. The whole underground system is probably a continuation of the karst system existing in the tunnel cover. It evacuated water from a vast area, which fact was proved by presence of pebbles of various rocks. Although this event slowed-down the works progress for a short time only, and the excavation continued without troubles after sealing off and draining water away from the tunnel.

běžně krasovění nepodléhají a ani zde se nevyskytl jiný projev krasovění. Celý podzemní systém je zřejmě pouze pokračováním krasového systému v nadloží tunelu a odváděl vodu z rozsáhlého okolí, o čemž svědčil výskyt valounků nejrůznějších hornin. Tato událost však pouze na krátkou dobu zpomalila postup prací a po zatěsnění a svedení vody mimo tunel pokračovala ražba bez problémů dál.

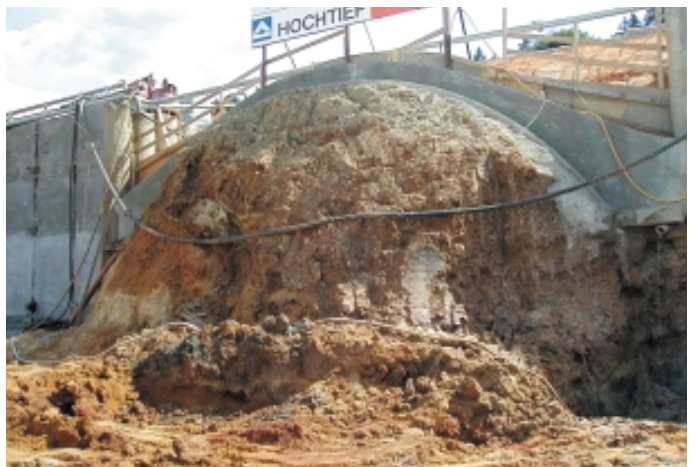
Obr. 7 Konstrukce „želvy“ na severním portálu Euerwang
Fig. 7 The "Turtle" vault structure at the North portal of the Eurwang tunnel

Portálový úsek je řešen želvou délky 48 m (obr. 7). Vzhledem ke specifickým geologickým podmínkám byla želva vybetonována mezi dvě pilotové stěny a sloužila tak jako rozpěra a náhrada kotvení pilotových stěn.

The portal section has been solved by the "Turtle" method within a length of 48 m (Fig. 7). Because of specific geological conditions, the vault was cast between two pile walls. Thus it served as bracing and substitution of the pile walls anchoring.
